**Eesti Energia AS**

**Survey report / Uuringu aruanne**

# **LIFE+ 09/ENV/227 OSAMAT ENVIRONMENTAL SURVEY RE- SULTS / KESKKONNASEIRE TULEMUSED**

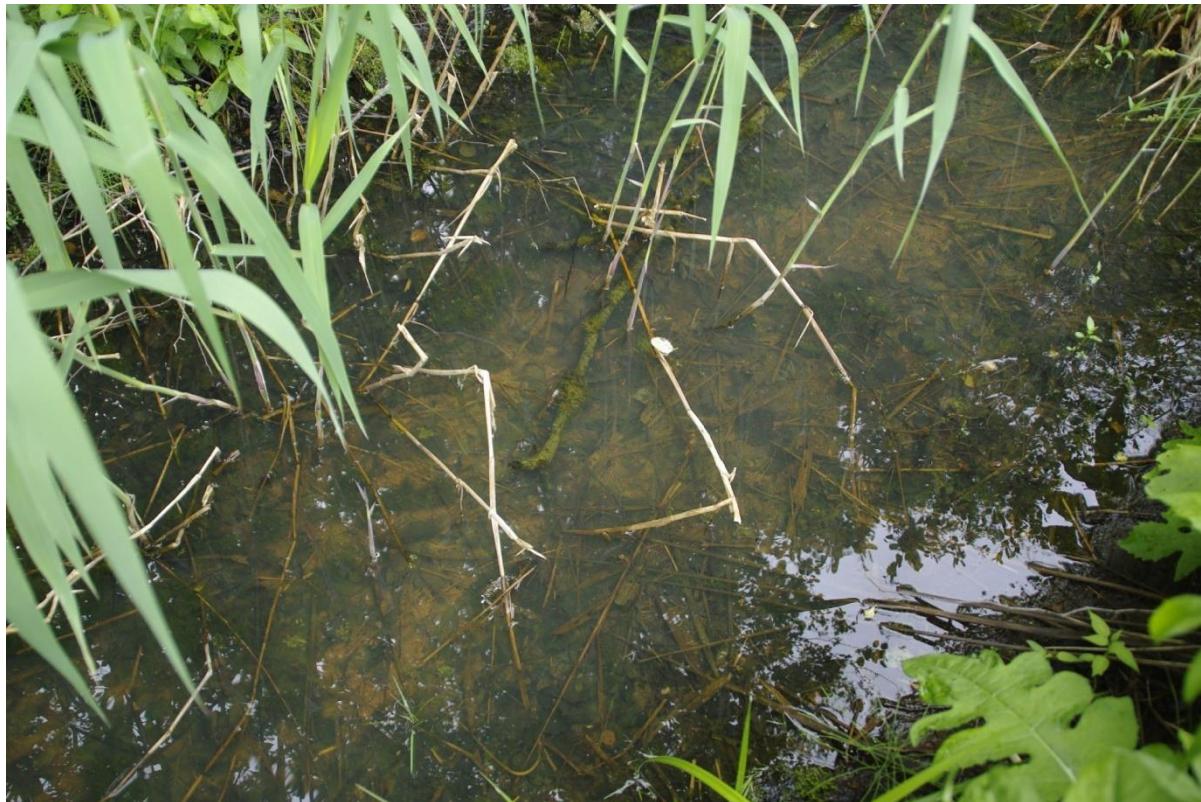
The water in the ditches that are located in the south side of the road was not clear and had greyish residue (Figure 2). This seems to indicate to the fact that the area is affected by the power plant's ash fields that may hinder the determination of the impact of stabilization as the effect of other factors cannot be excluded.

Kohati ei olnud teest lõuna pool oleva kraavi vesi selge, vaid omas hallikat sadet (Figure 2), mis võiks viidata sellele, et piirkonna vett mõjutavad elektrijaamade tuhaväljakud. See aga võib takistada stabiliseerimise mõju kindlaks tegemist, kuna ei saa välistada teiste tegurite mõju olemasolu.

**Figure 2. The ditch water of Narva-Mustajõe road section at the sampling site / Narva-Mustajõe teelõigu kraavivesi proovivõtukohas (20.06.2011).**

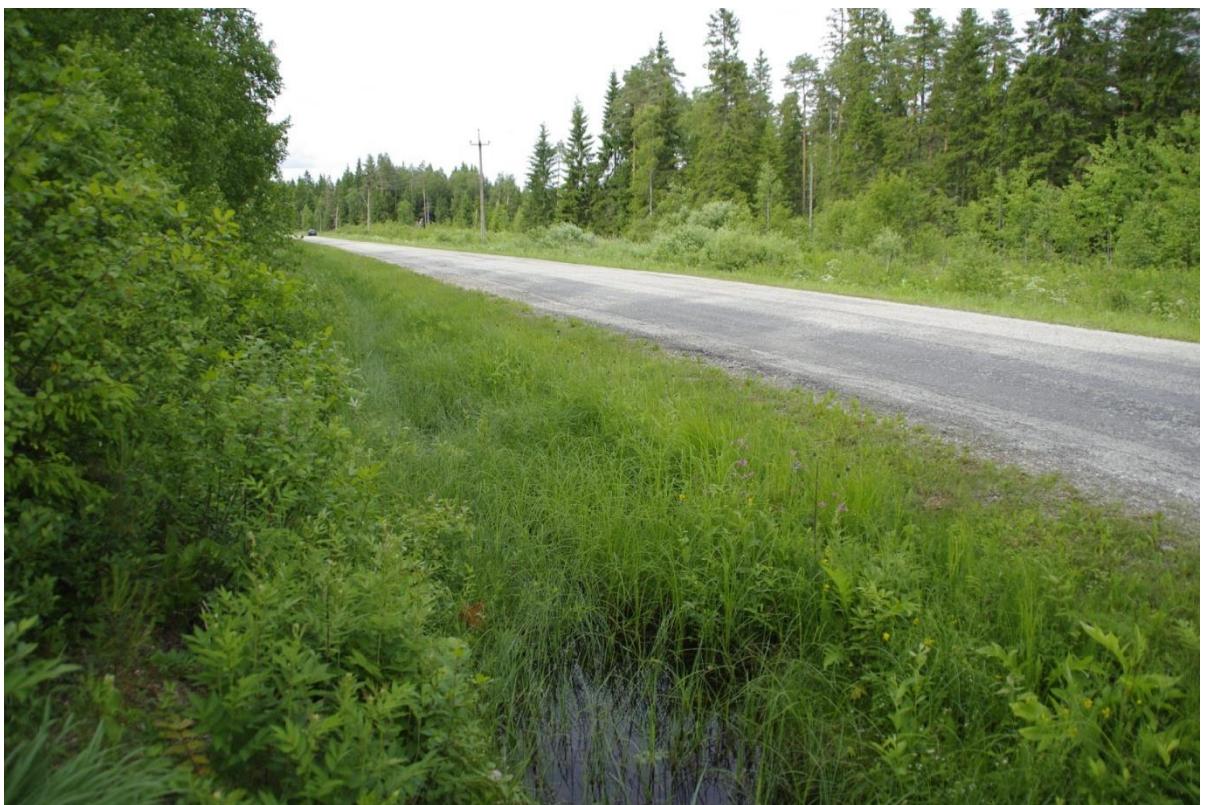
The site visit showed that the Simuna-Vaiatu road no 1719 section 2.5 km was clearly ditched from the west side of the road (Figure 3), therefore the ditches in the east were either shallow or in some cases in parallel with the road. For

Objektikülastuse tulemusel (20.06.2011) selgus, et mnt nr 17192 **Simuna-Vaiatu** teelõik km 2,5 oli selgelt kraavitud lääne poolt teed (Figure 3), samas ida poolt oli kraav kas madal või oli mõnes kohas paralleelselt teega mi-

**Figure 3. The western ditch of the Simuna-Vaiatu road section (20.06.2011) / Simuna-Vaiatu teelõigu läänepoolne kraav 20.06.2011**

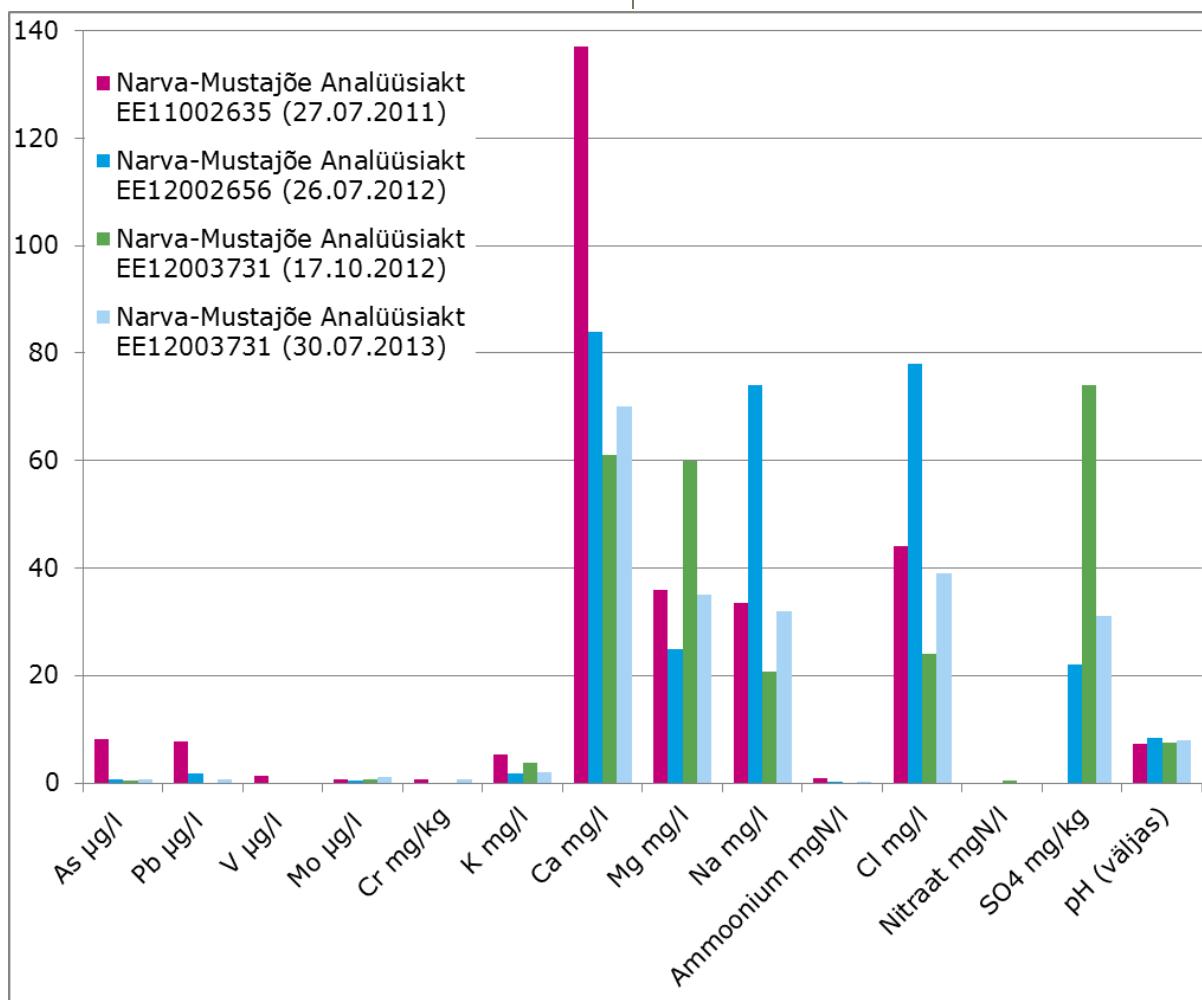
All the results of Narva-Mustajõe water samples are presented in the figure below (Figure 5). These results show that the concentration levels of heavy metal/hazardous substances have not increased after the road construction. Rather, it can be inferred from the results that the reconstruction of the ditches and water system during the road construction improved the overall water quality and all changes in water quality after that are so small that they cannot be connected to the impact of test section.

Kõik Narva-Mustajõe veeproovide tulemused on esitatud alljärgneval joonisel (Figure 5), millest selgub, et tee-ehitus ei ole põhjustanud ühegi raskmetalli/ohtliku aine kontsentratsiooni tõusu. Pigem võib tulemustest järelledaada, et tee-ehitusega kaasnenud kraavide puastus ja veesüsteemi korda tegemine on üleüldist veevaliteeti ümbruskonnas pigem parandanud ning kõik seejärel toimunud veevaliteedi muutused on niivõrd väikesed, et neid katseõigu mõjuga seostada ei saa.

**Figure 5. The results of the water samples of Narva-Mustajõe test section / Narva-Mustajõe teelõigu veeproovide tulemused**

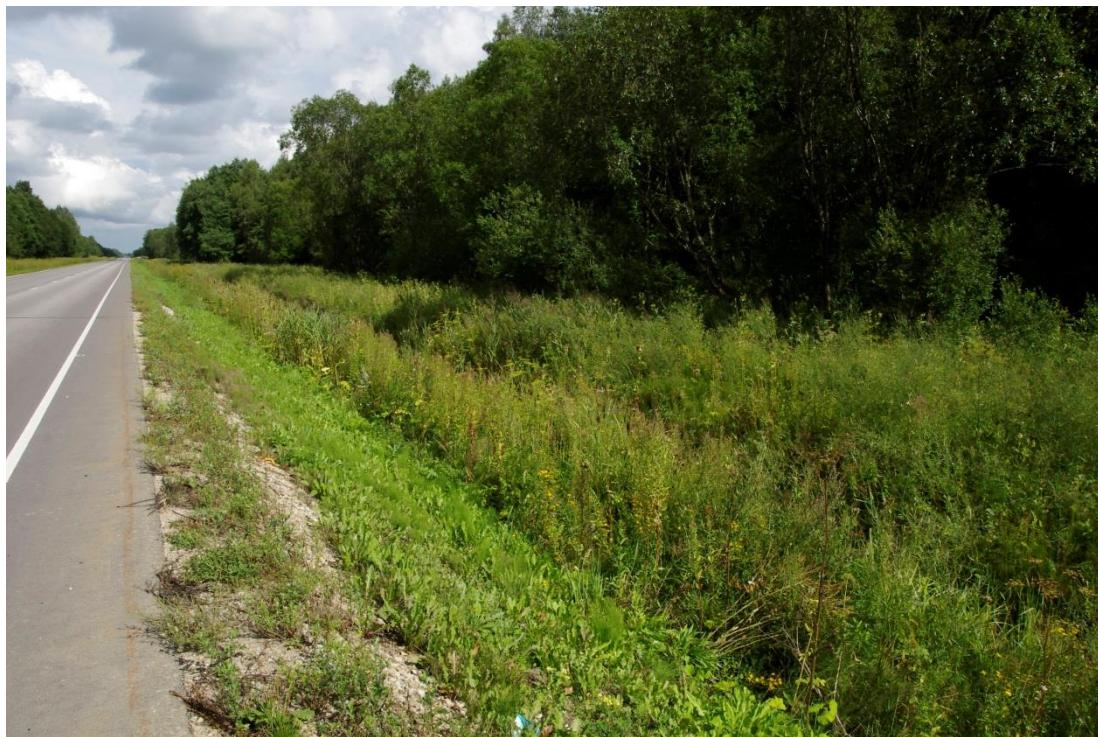
**Figure 9. View on the southern side of the road embankment and the southern side ditch towards Narva, summer 2013 (R. Pajula) / Vaade Narva suunas teemulde lõuna-küljele ja lõunapoolsele külgkraavile 2013. aasta suvel (R. Pajula)**

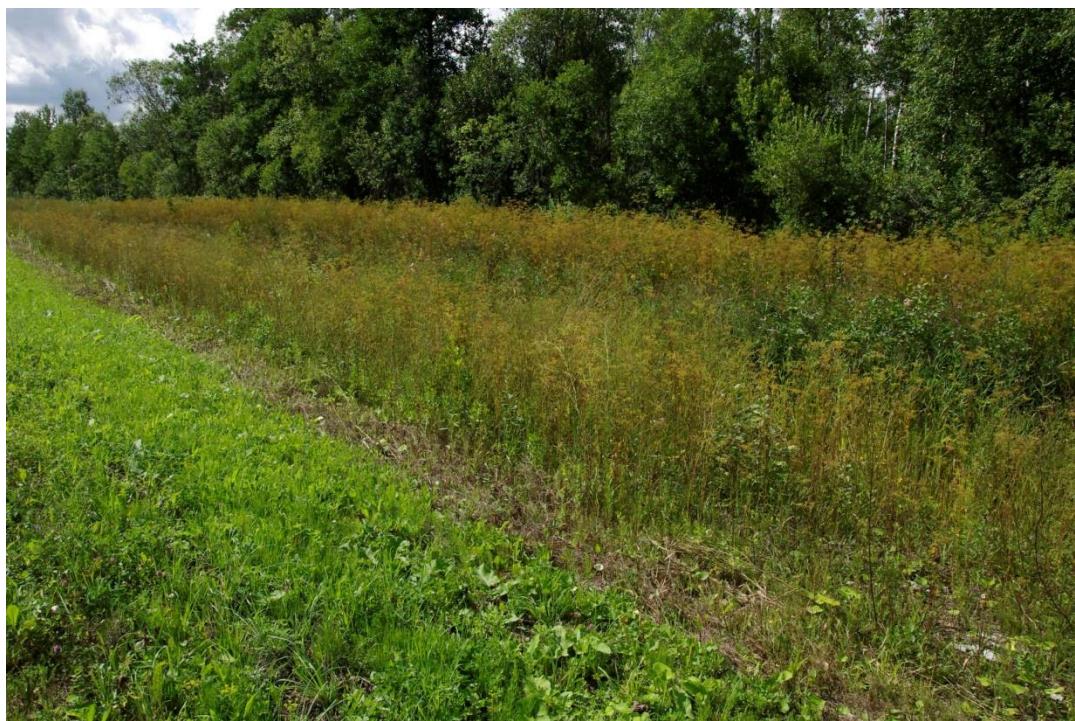
**Figure 10. View on the northern side of the road embankment and the northern side ditch towards Mustajõe (2013). Ditch is farther on the northern side and the area to be mown is wider as well (R. Pajula) / Vaade Mustajõe suunas teemulde põhjaküljele ja põhjapoolsele külgkraavile (2013). Põhjaküljel asetseb kraav kaugemal ning niidetava ala on laiem (R. Pajula)**

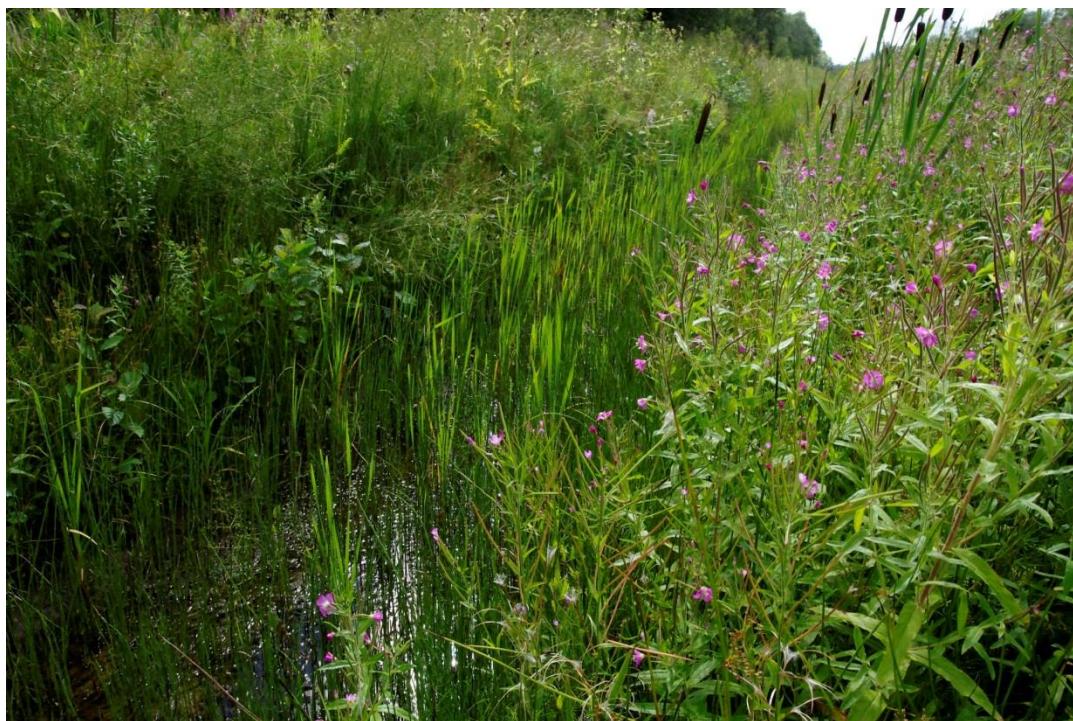
**Figure 11. Ample flora with dominating water horsetail, cattail and fireweed in the southern ditch and on the banks (2013, R. Pajula) / Lopsakas taimestik konnaosja, hundinuia ja põdrakanepi domineerimisega lõunapoolses külgkraavis ja selle kallastel (2013, R. Pajula)**

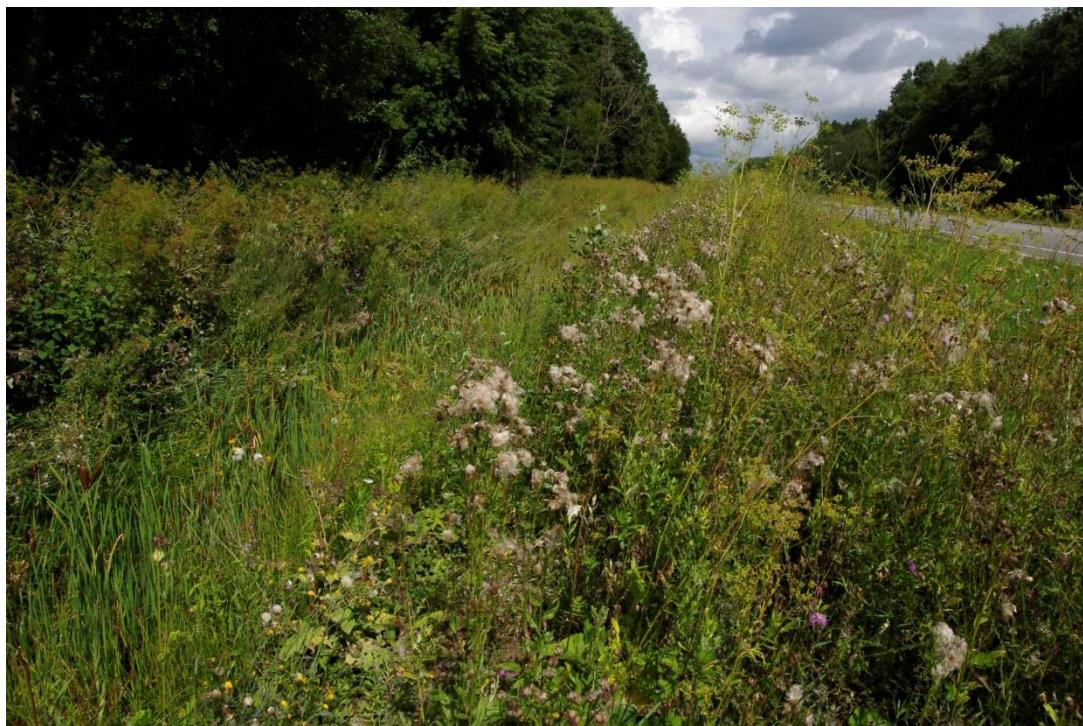
**Figure 12. View on the northern slope of the road embankment and the northern side ditch. Creeping thistle and parsnip dominate on the slope, cattail on the ditch (2013, R. Pajula) / Vaade Narva suunas teemulde põhjanõlvale ning põhjapoolsele külgkraavile. Nõlval domineerib pöldohakas ja moorputk, kraavis hundinui (2013, R. Pajula)**

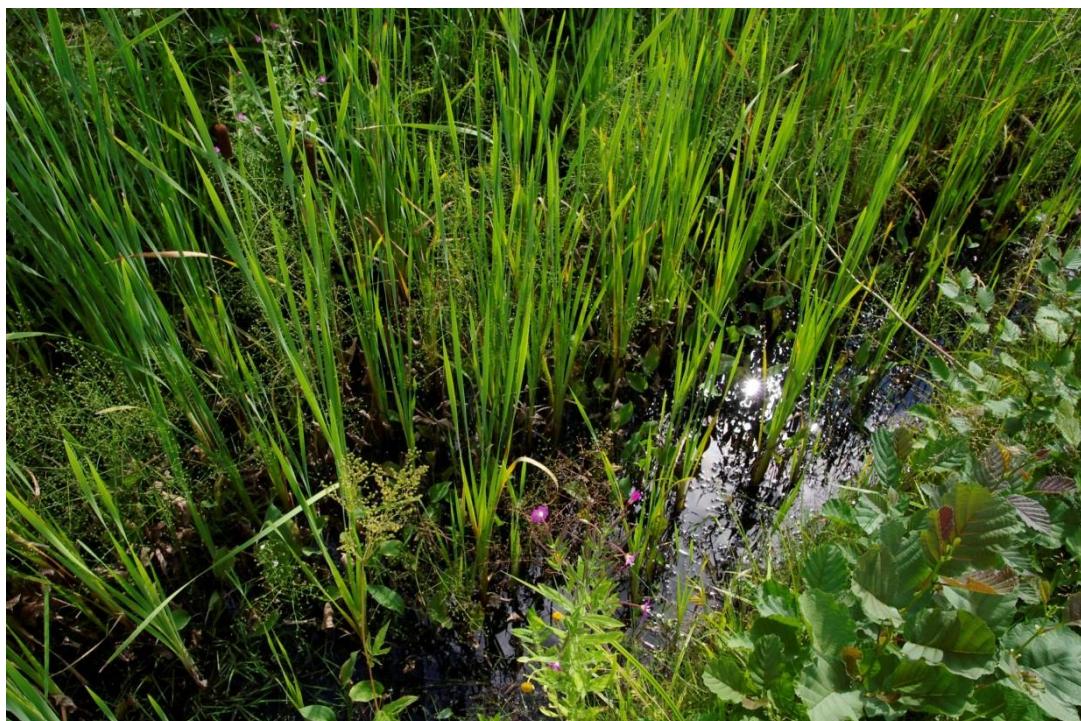
**Figure 13. Flora with dominating cattail and water horsetail in the southern ditch (2013, R. Pajula) / Hundinuia ja konnarohu domineerimisega taimestik lõunapoolses külkraavis (2013, R. Pajula)**

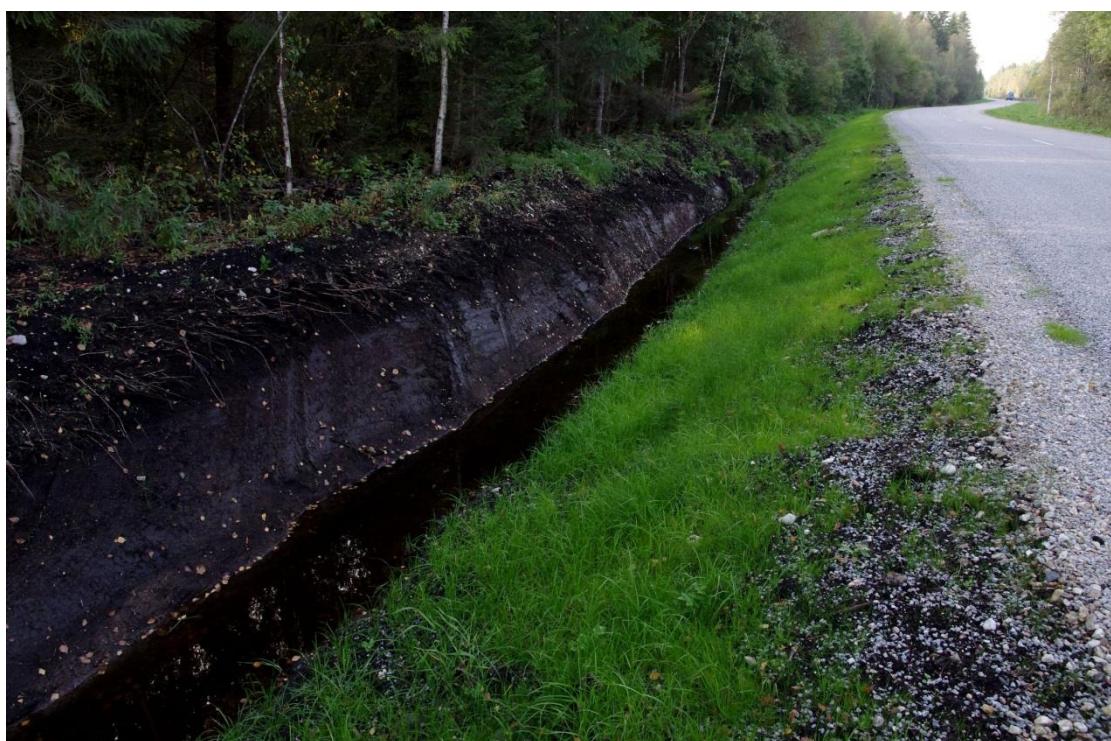
**Figure 16. The vegetation in the right (western side) road edge of the middle side of the test section in 2014, view looking to the north. Grass is sown on the road embankment, the dredged outside area is not vegetated (2014, R. Pajula) / Katselõigu keskosa parema (läänepoolse) teeserva taimkate 2014. aastal, vaade põhja suunas. Mulde nõl-**

vale on külvatud muru, süvendatud külkraavi väliskallas on taimestumata (2014, R. Pajula)

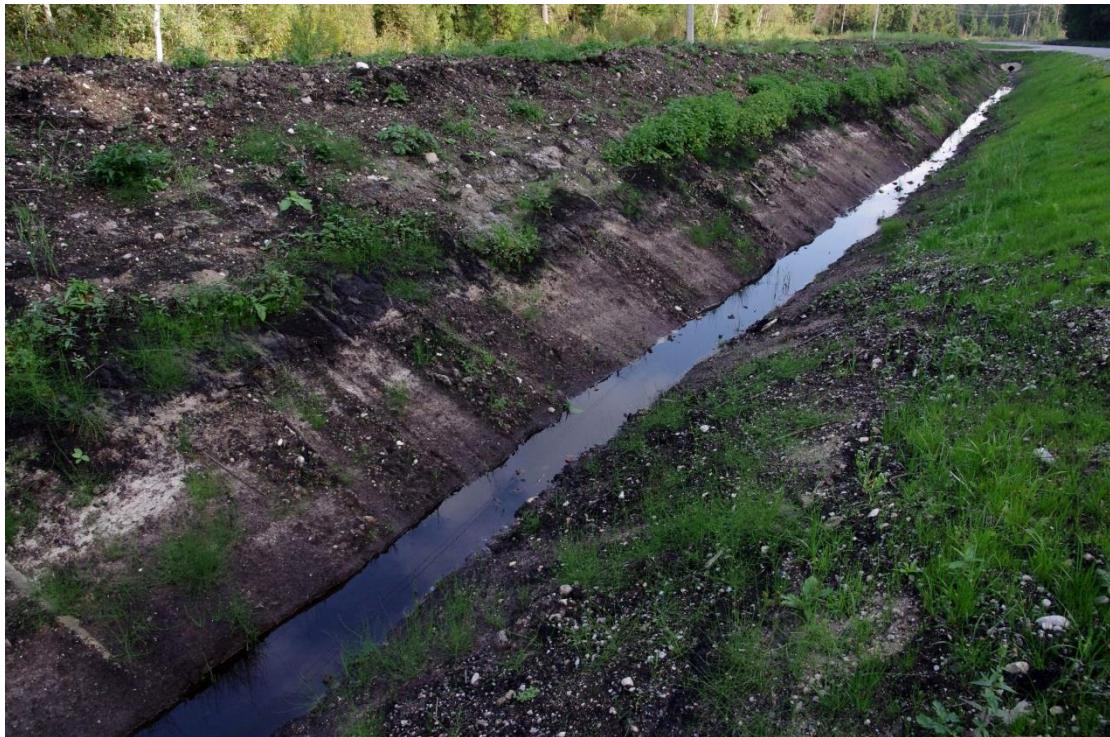
**Figure 17. The left (eastern side) road edge of the southern side of the test section in 2014, view looking to the south. Soil from road dredging works has been deposited onto the outside area behind the ditch (2014, R. Pajula) / Katselõigu lõunaosa vasak (idapoolne) teeserv 2014. aastal, vaade lõuna suunas. Kraavi taha on ladestatud ja tasandatud tööde käigus üle jäänud pinnast (2014, R. Pajula)**

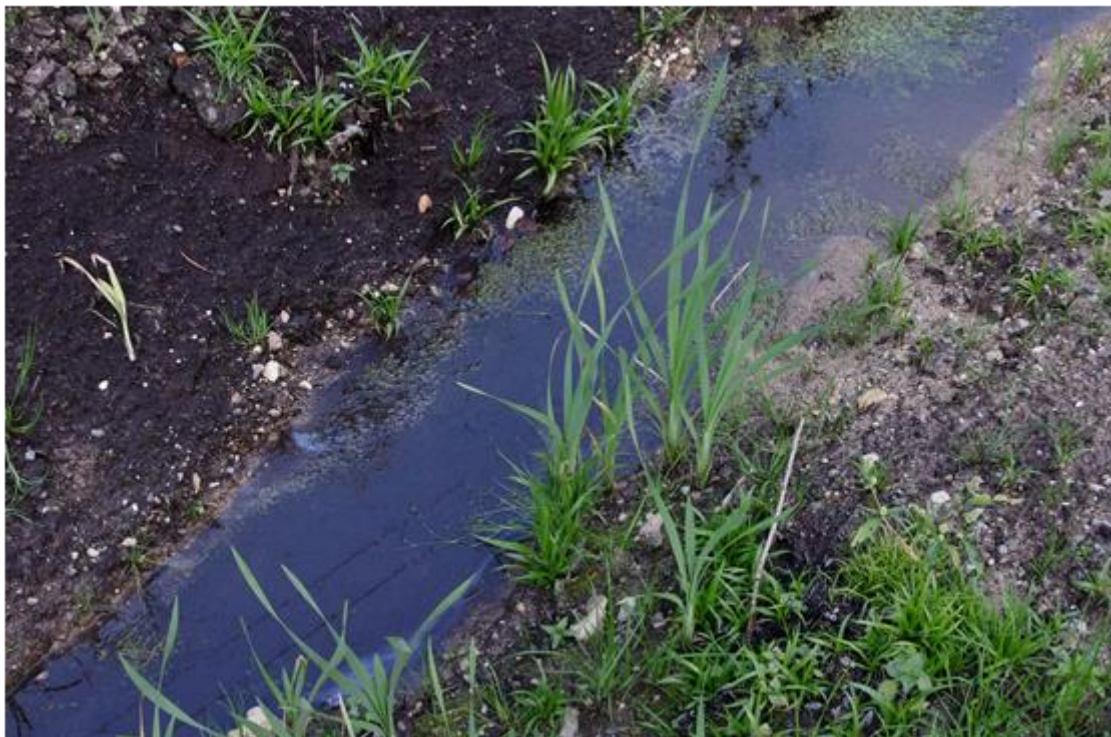
**Figure 18. Emerging moisture-loving vegetation in the bottom of the roadside ditch in 2014 (2014, R. Pajula) / Kujunemisjärgus niiskuslembene taimkate külkraavi põhjas, katselöigu keskosas 2014. aastal (2014, R. Pajula)**
