Intended for  
**Eesti Energia**

Document type  
**Materials action Pilot report including descriptions of applications**  
For Materials Action see another report

Date  
**January 2015**

# **LIFE+ 09/ENV/227 OSAMAT APPLICATIONS, PILOTING AND VERIFICATION ACTIONS NARVA-MUSTAJÕE PILOT REPORT**

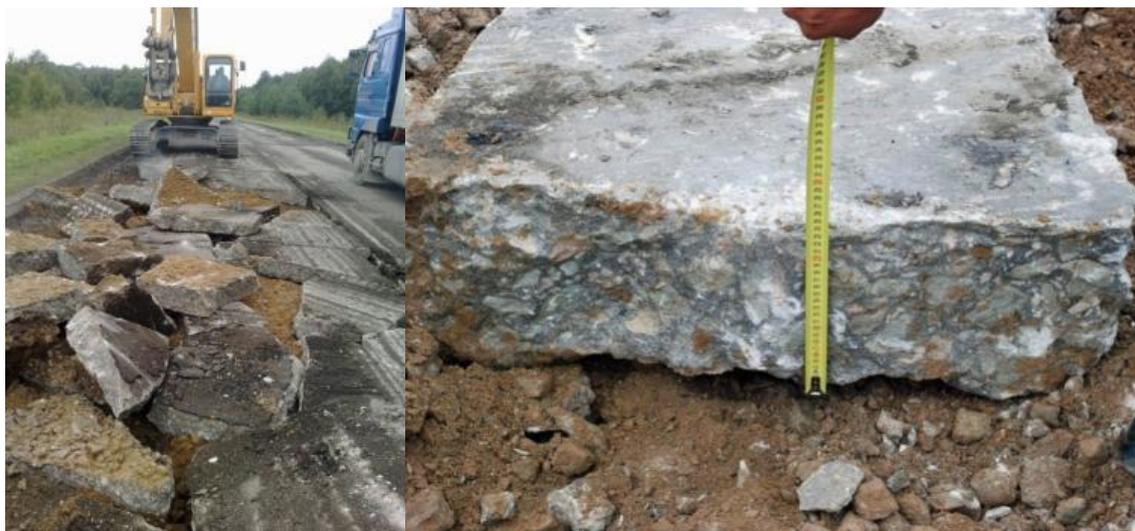
**Figure 2-2. The concrete layer found below the pavement**

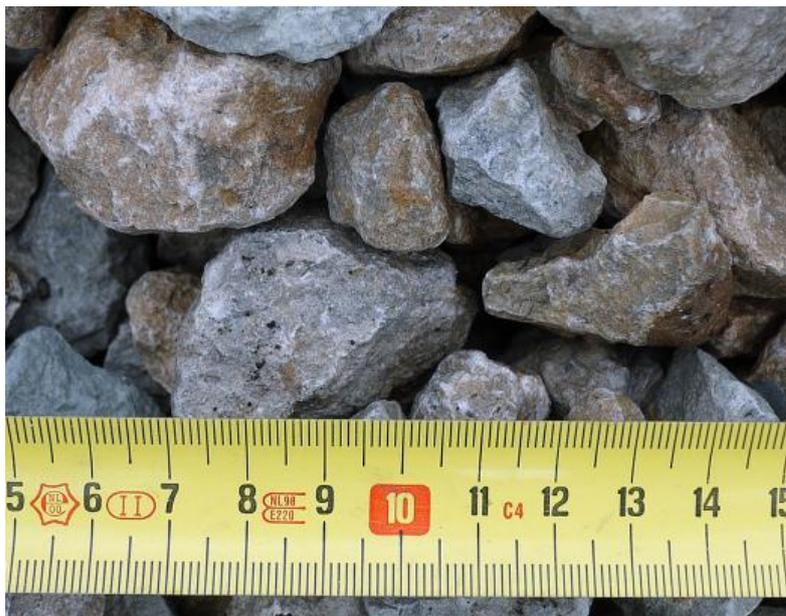
Figure 3-7. Aidu 16-32 mm aggregate

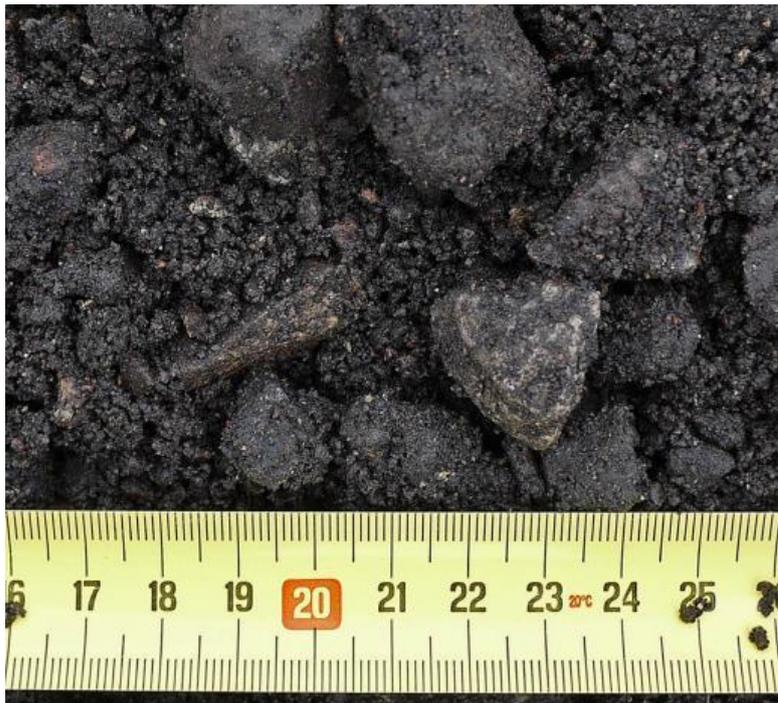
**Figure 3-8. Milled and crushed asphalt concrete (MAC)**

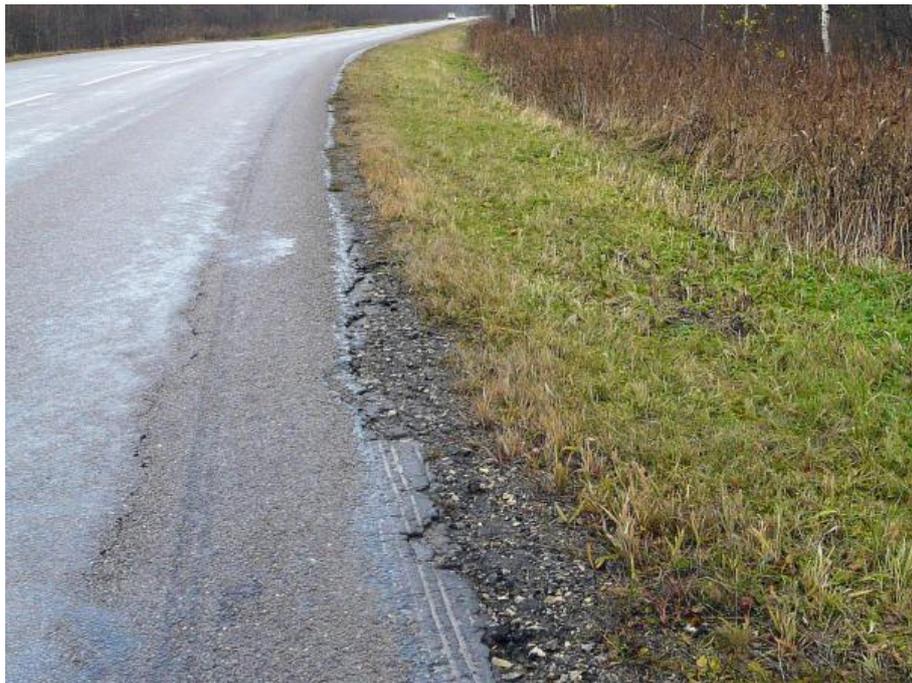
**Figure 3-10. AC surface set lower on road side (Oct 2010)**

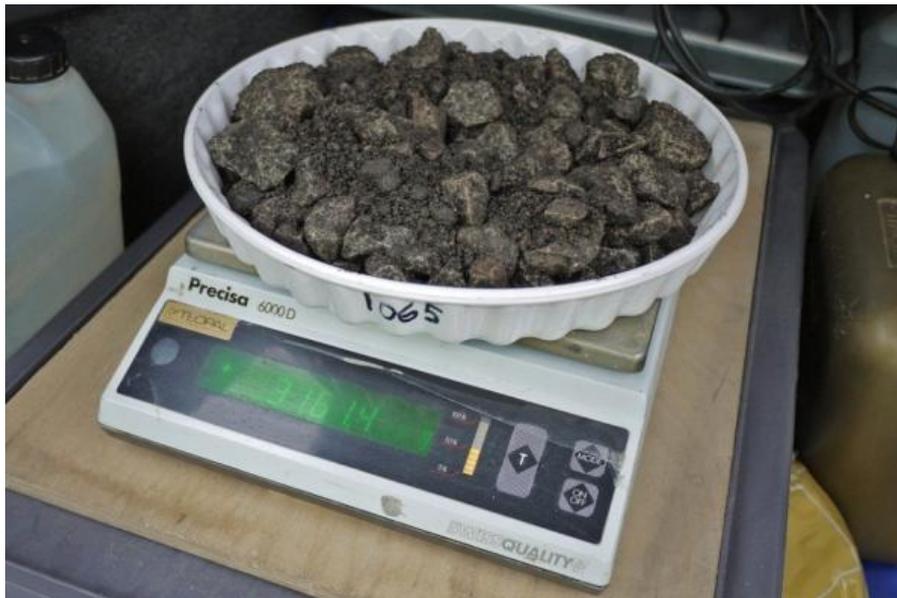
The water content of the body material (mining waste aggregate and crushed asphalt concrete, Figure 4-2) was measured in a few different points and it was between 5.5 and 5.7 %. Compact of the body material was also analysed as the materials, which were tested in the laboratory varied compared to the body material on the road.

Figure 4-2. Dried body material weighed for water content analyses

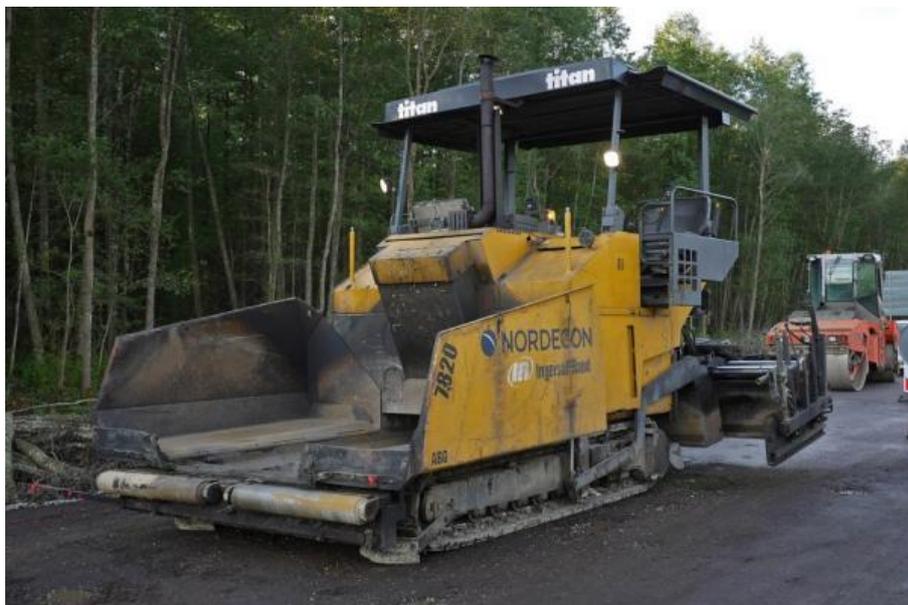
Figure 4-3. Asphalt paver used for wet binding agent mixture spreading

Stabilisation works were supposed to commence at 7.00, but the concrete factory, which was in charge of the binding agent mixing had problems with the mixing process. At 10.00, one full 15 tonne lorry load of binding agent mixture (6% of OSA EF PF and 3% CC) was ready for stabilisation mixing. However, there were problems connecting the lorry platform to the asphalt paver (Figure 4-3 and Figure 4-4) and also with getting the binding agent mixture out of the platform. Eventually, the whole load of binding agent mixture was emptied onto the road and loaded to the asphalt paver with a Bobcat (Figure 4-5).

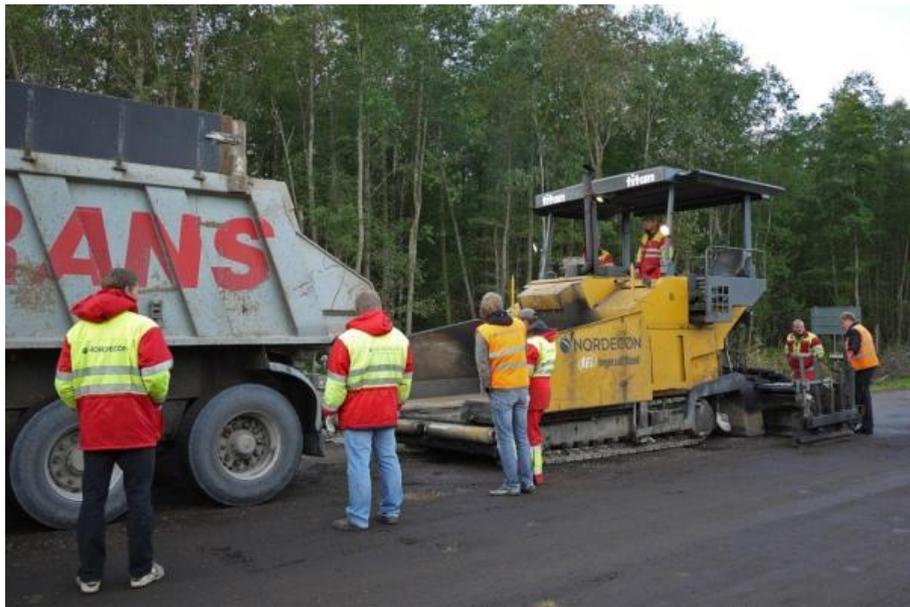
**Figure 4-4. Trying to connect the truck and paver**

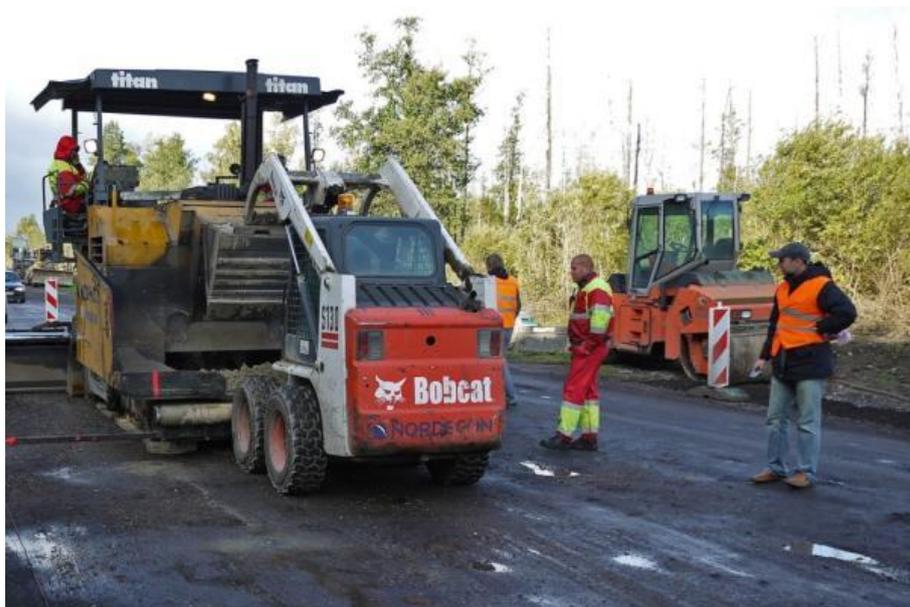
**Figure 4-5. Bobcat filling the asphalt paver punker**

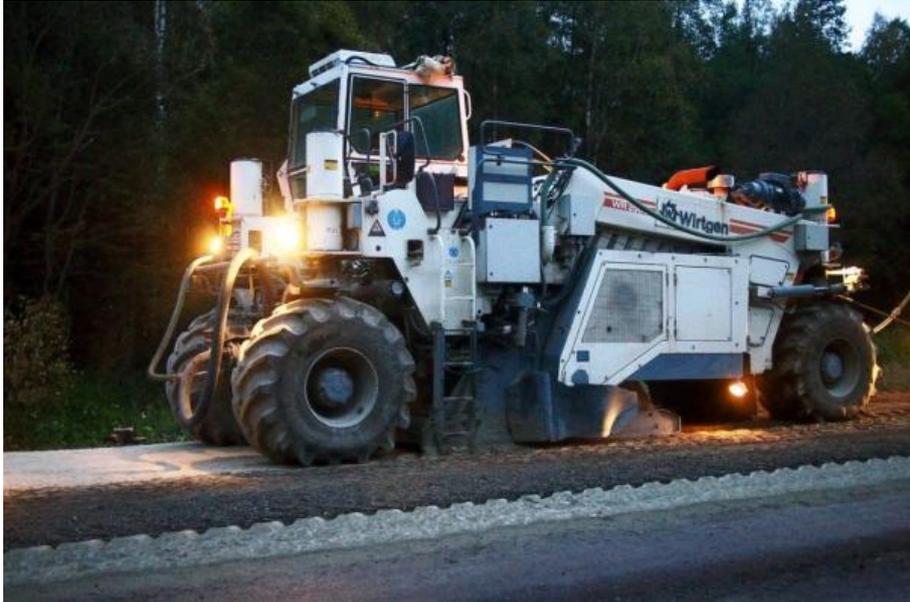
**Figure 4-6. The Rotary mixer used in stabilisation work**

The first batch of stabilisation was tested with the first 15-tonne truckload of wet binding agent mixture. Width of the mixing drum of the rotary mixer used for stabilisation work was approximately half of the width of one lane, thus both of the lanes were divided into two sides.

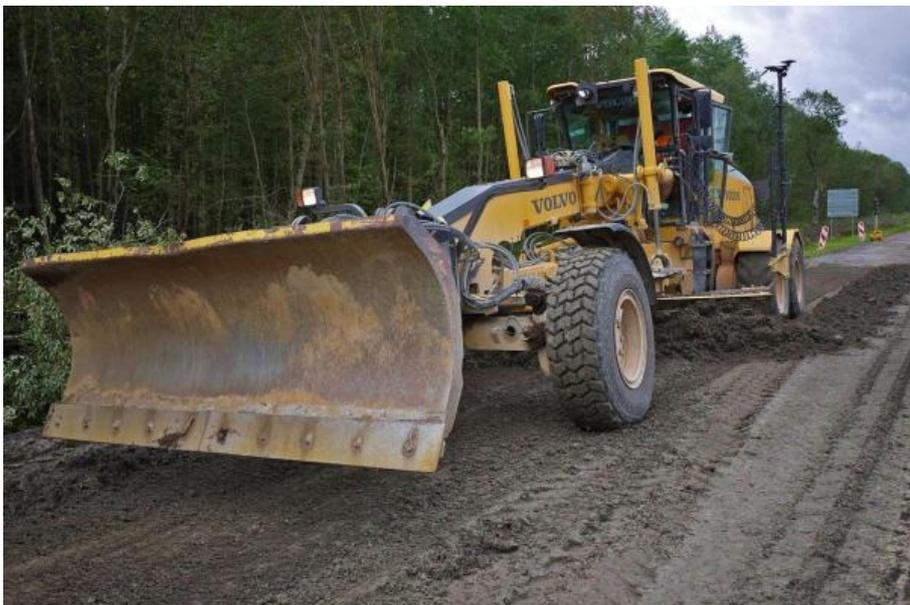
**Figure 4-7. Road grader shaping freshly mixed road base**

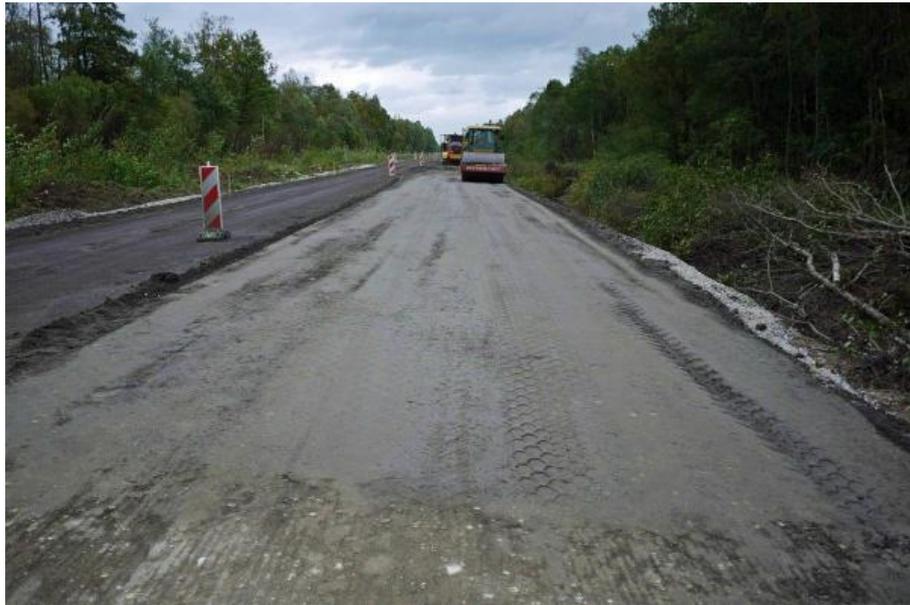
**Figure 4-8. The first batch of stabilisation mixing after grading and compaction**

After the second round of mixing, grading and compaction, the test section was left untouched over the next night (Figure 4-8).

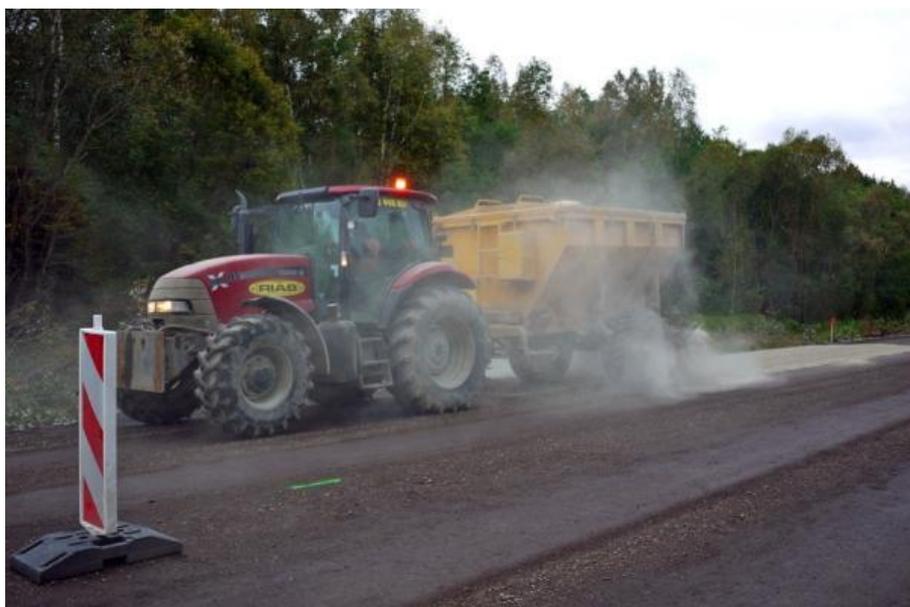
**Figure 4-9. Tractor-pulled cement spreading car**

Because of the mixing problems at the concrete factory, it was decided to spread the binder in dry form with a cement spreading car (Figure 4-9). The dry binding agent mixing was used for the rest of the day. Dry spreading was started at STA 5+00 with the cyclone ash and Komposittsement binding agent composition (5% OSA CYCL. and 5% of CC). In the end of the day, stabilisation on the right lane was finished until STA 7+25 without any bigger problems.

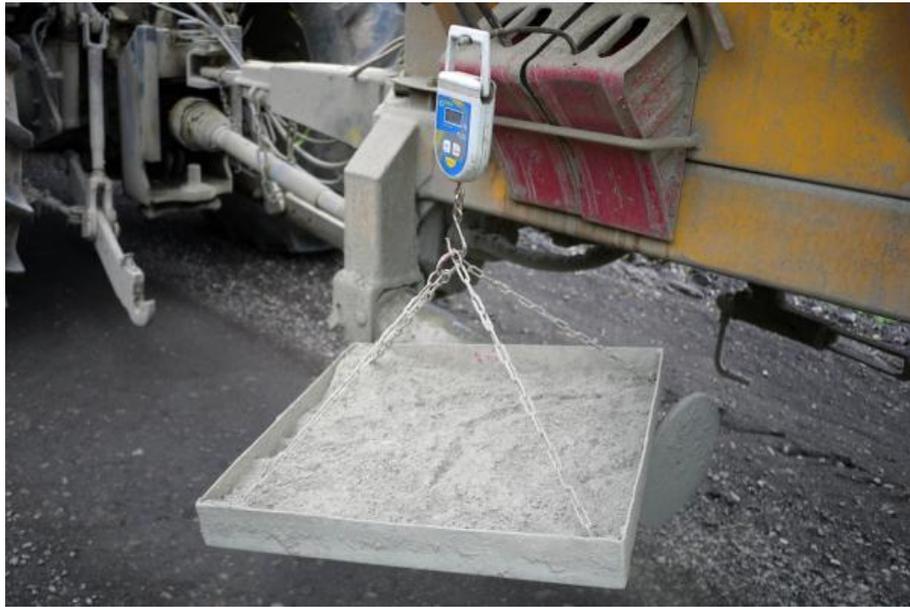
**Figure 4-10. Binding agent spread measurement during spreading**

The dry binding agents were spread and mixed in two phases. Cement was spread first and mixed into the aggregate layer without any added water. The surface of the road was quickly graded after the first round of mixing. After that, fly ash was spread and mixed into the road with 5 l/m<sup>2</sup> added water. The spreading car operator calibrated the spreading amount by weighing the binding agent spread on a 0.25 m<sup>2</sup> container (Figure 4-10).

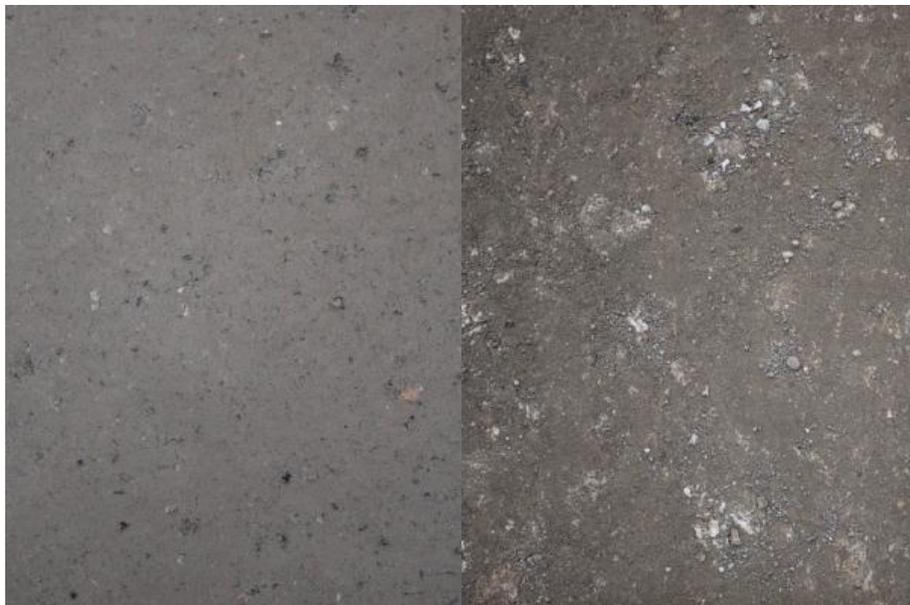
First thing in the morning, the wet binding agent mixed section (STA 0+50-0+75) was checked and it was seemingly hardened enough for traffic use. The surface was very smooth and had no detached material on it. Figure 4-11 shows comparison of the surfaces of “too wet section” and “drier section” one day after stabilisation.

**Figure 4-11. Left: surface of the „too wet section”, right: surface of the „drier section”**

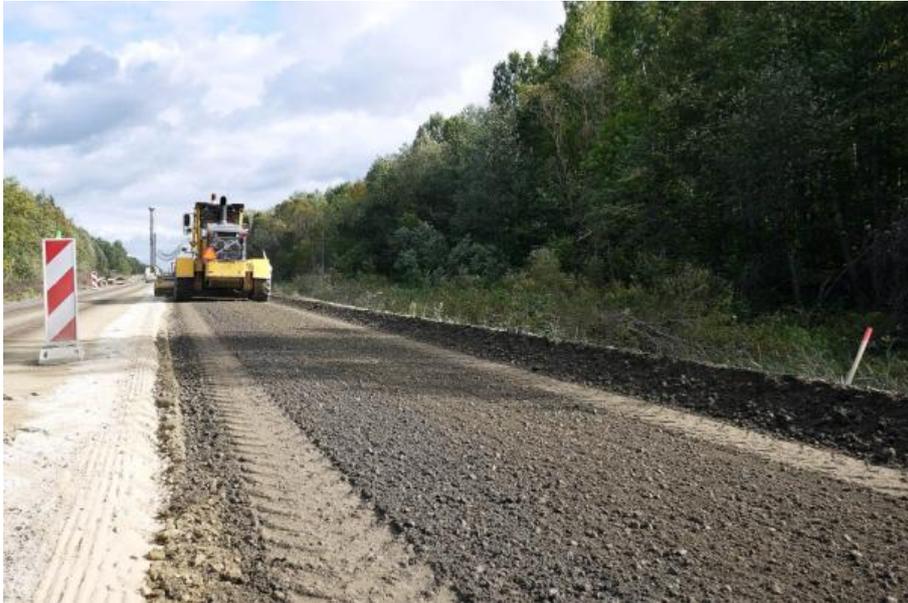
After STA 8+00 7 l/m<sup>2</sup> of water was added at the beginning, but it was quickly raised to 9 l/m<sup>2</sup> as the material seemed to be too dry ( $w = 6.1\%$ ). After changing the added water amount to 9 l/m<sup>2</sup>, the measured water content was between 6.7% and 8.2%. For some reason, the centre sector of the right lane was wetter (8.2%) than the side contrary to experiences acquired a day before even though the added water amount was the same for the both sides. The “too wet” material could be easily seen from the surface (Figure 4-12).

**Figure 4-12. Too wet material in the centre sector of freshly stabilised section at STA 8+50**

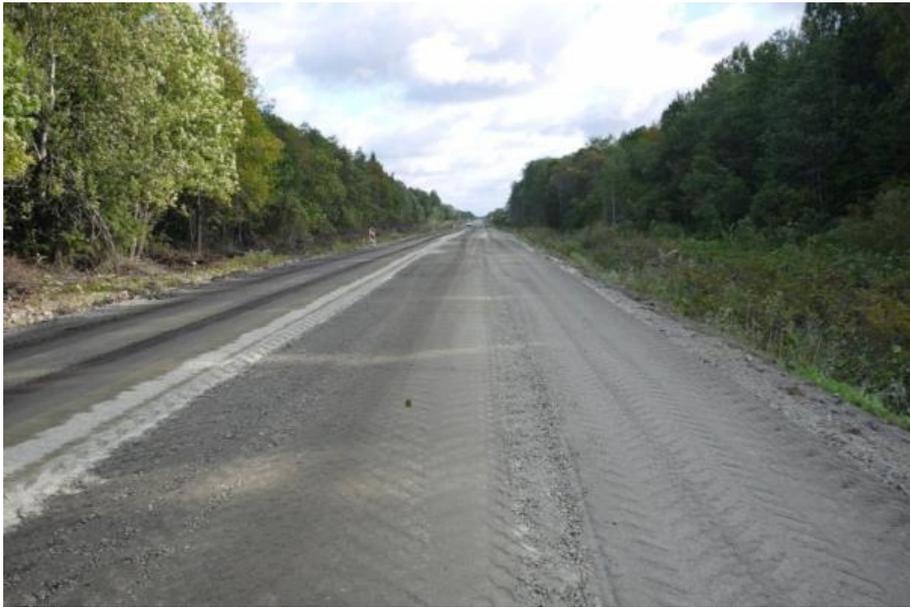
**Figure 4-13. Grain size sorting on the surface of freshly stabilised section. The lane was stabilised in two rotary mixer runs and the coarser looking tracks are located in the extreme left side of the Rotary mixer track**

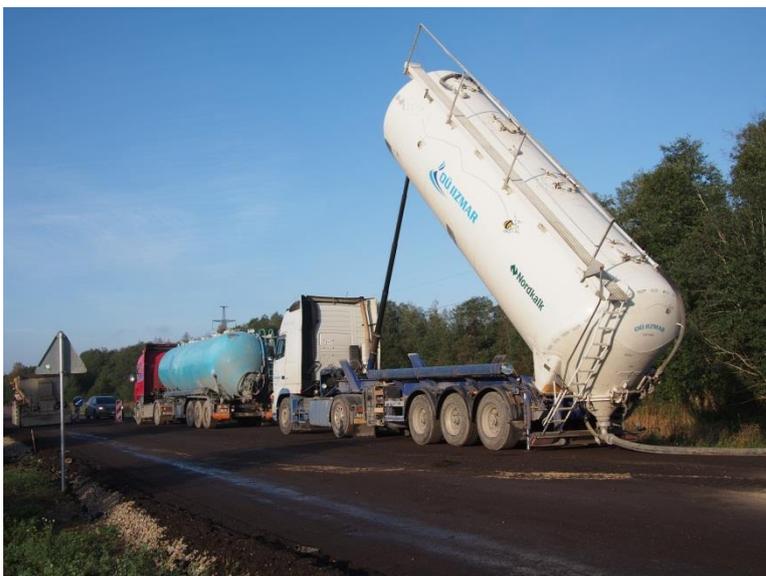
**Figure 4-14. Binder transporting to the construction site**

A part of stabilisation works, which couldn't be constructed in year 2011. The needed binder was not available. At the beginning of October 2012 the works have been finalised using same construction methods as 1 year before. There are shown two machine pictures in Figure 4-14 and Figure 4-15.

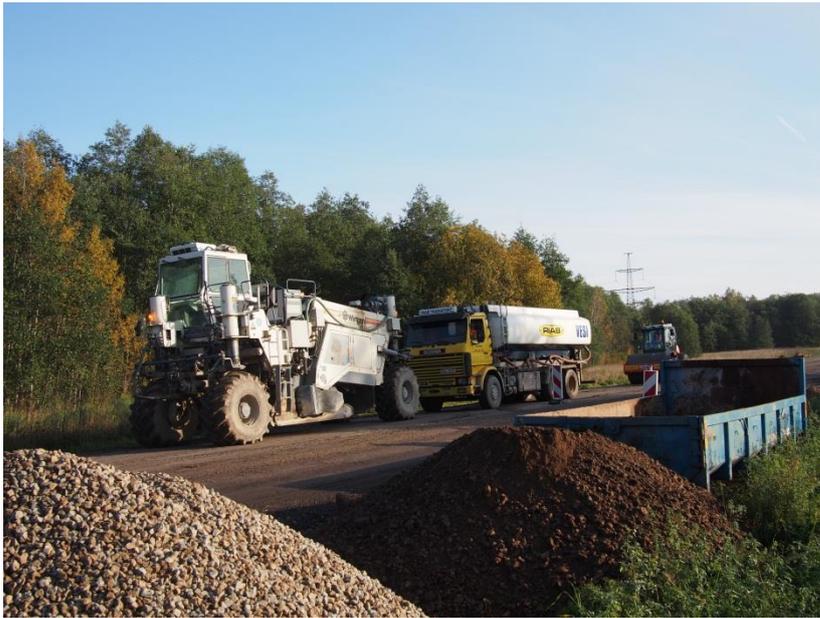
**Figure 4-15. Rotary mixer and water transporting**

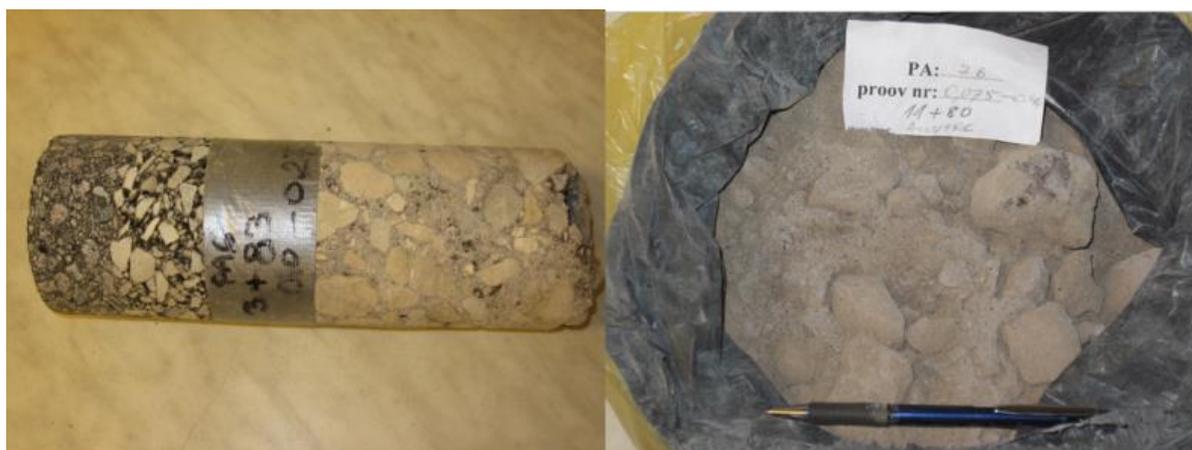
The following pictures represent the remarks on the quality of the sample. The word 'piece' means that the sample is intact and the word 'loose' means that sample material is destroyed during the drilling. The loose material doesn't hold its form for proper material testing as can be seen from the picture below (Figure 6-1).

**Figure 6-1. Example of piece: sample 6, and loose: sample 26**

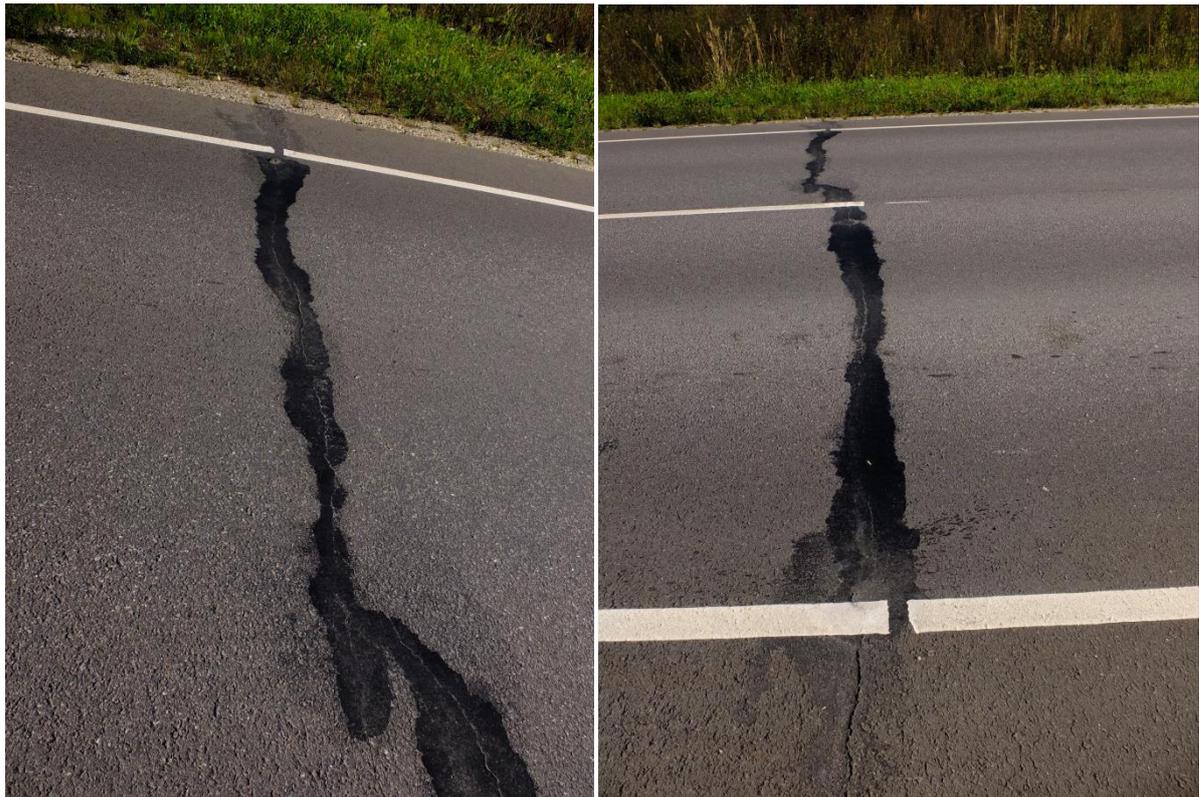
**Figure 6-2. Transverse crack in 2013**

The defect count analysis have also been made in three consecutive autumns (2012-2014), the results are given in Table 6-3. On the first 450 m there are more transverse cracks than on the following 450 m. It is typical for stabilized structures that there are narrow cracks. They are caused by shrinking of the stabilized layer, very typical for stabilisation of coarse materials with hydraulic binders. Typically they are transverse-type cracks (see Figure 6-2). Such cracks are often formed immediately within hardening process of material and generally not growing further. There are also some longitudinal cracks, usually caused by frost. The joint crack is in the asphalt joint. Places of fatigue cracking indicate problems in the pavement structure. In present case those are probably results of works quality.
