Document type
Materials action Pilot report including descriptions of applications
For Materials Action see another report

Date
January 2015

LIFE+ 09/ENV/227 OSAMAT APPLICATIONS, PILOTING AND VERIFICATION ACTIONS SIMUNA-VAIATU PILOT REPORT

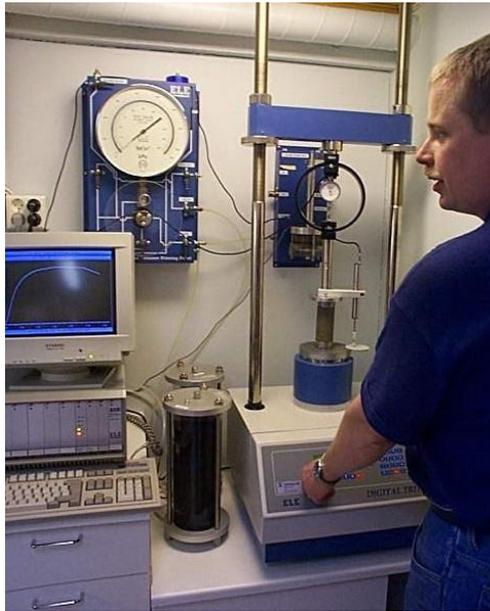
- **Unconfined Compressive Strength, UCS**, is a standard test where a cylindrical test piece is subjected to a steadily increasing axial load until failure occurs. The axial load is the only force or stress applied. The rate of the load is 1 - 2 mm/min. If any noticeable failure does not occur, the maximum value of the compression strength is taken when the deformation (change of height) is 15%. Usually, the test will be made on test pieces after at least 28-30 days stabilisation. The Photo 3-1 shows the test in progress.

Photo 3-1 Unconfined compressive test in progress.

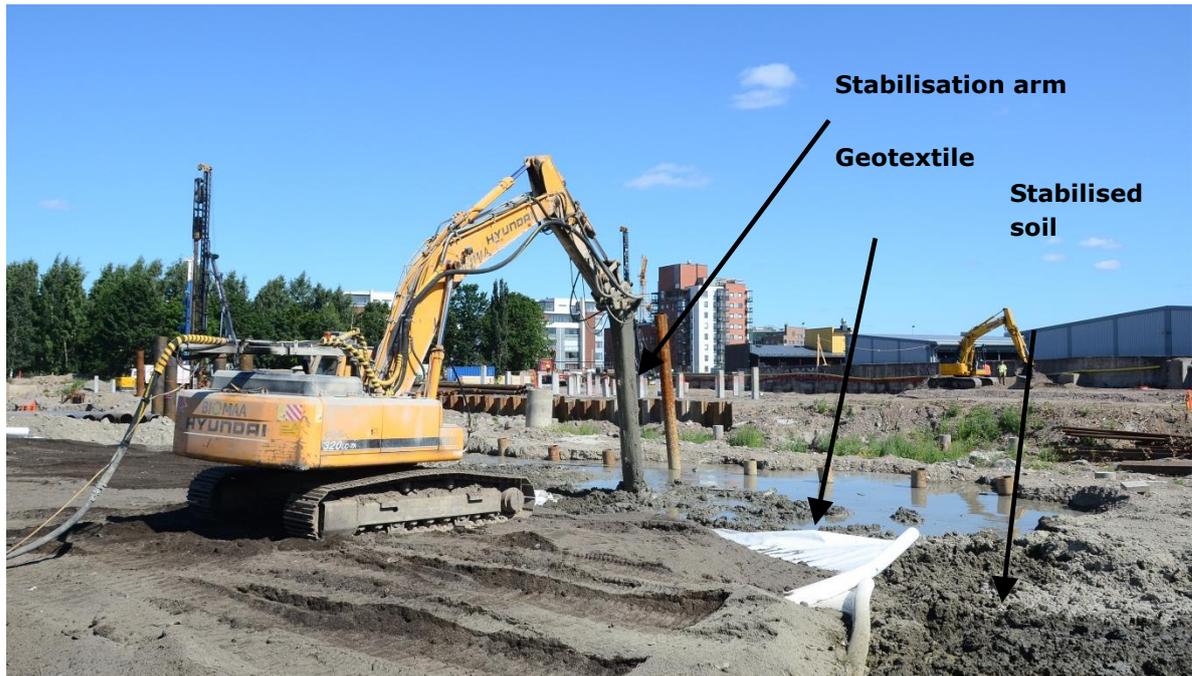
The ground on which the stabilisation equipment operates must provide a stable base. To assure a good stable base, a blanket granular material is placed and rolled into a flat working platform. The mass stabilisation equipment, geotextile, pre-loading embankment and stabilised soil are represented on the Figure 4-1.

Figure 4-1 Mass stabilisation equipment stabilising clay

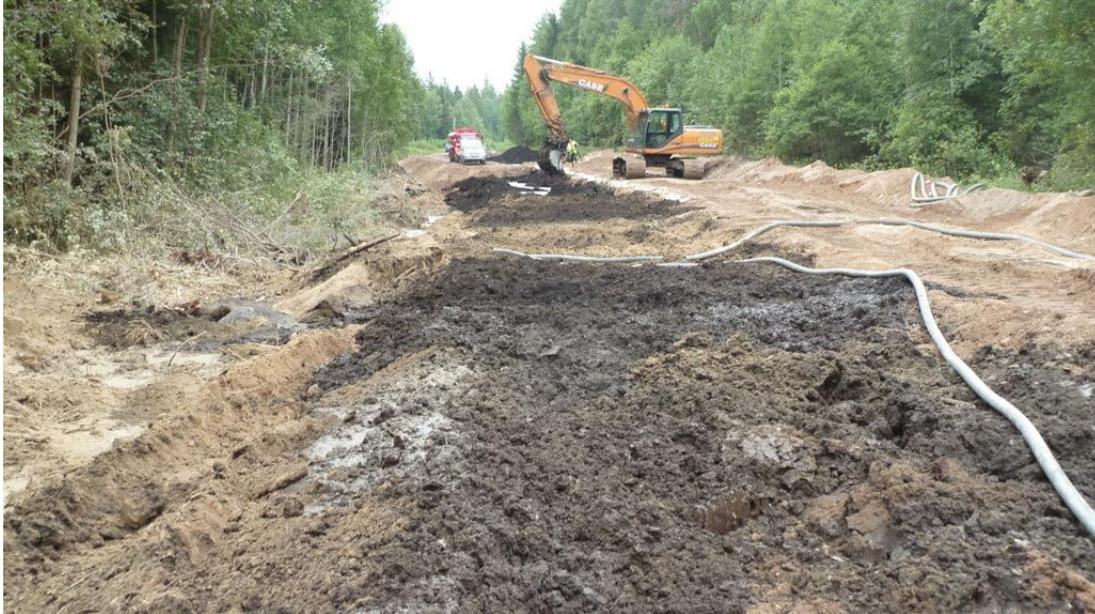
Photo 4-1 Removal of topsoil

up to the peat layer was then placed on the opposite side of the road and flattened out afterwards. This was done in both, left and right sides of the road. Amounts of natural and scrap gravel were hauled from the quarry. The stabilised road section was then coated with geotextiles. The road sections under construction in week two varied from STA 32+60-33+00 to STA 35+00-37+60.

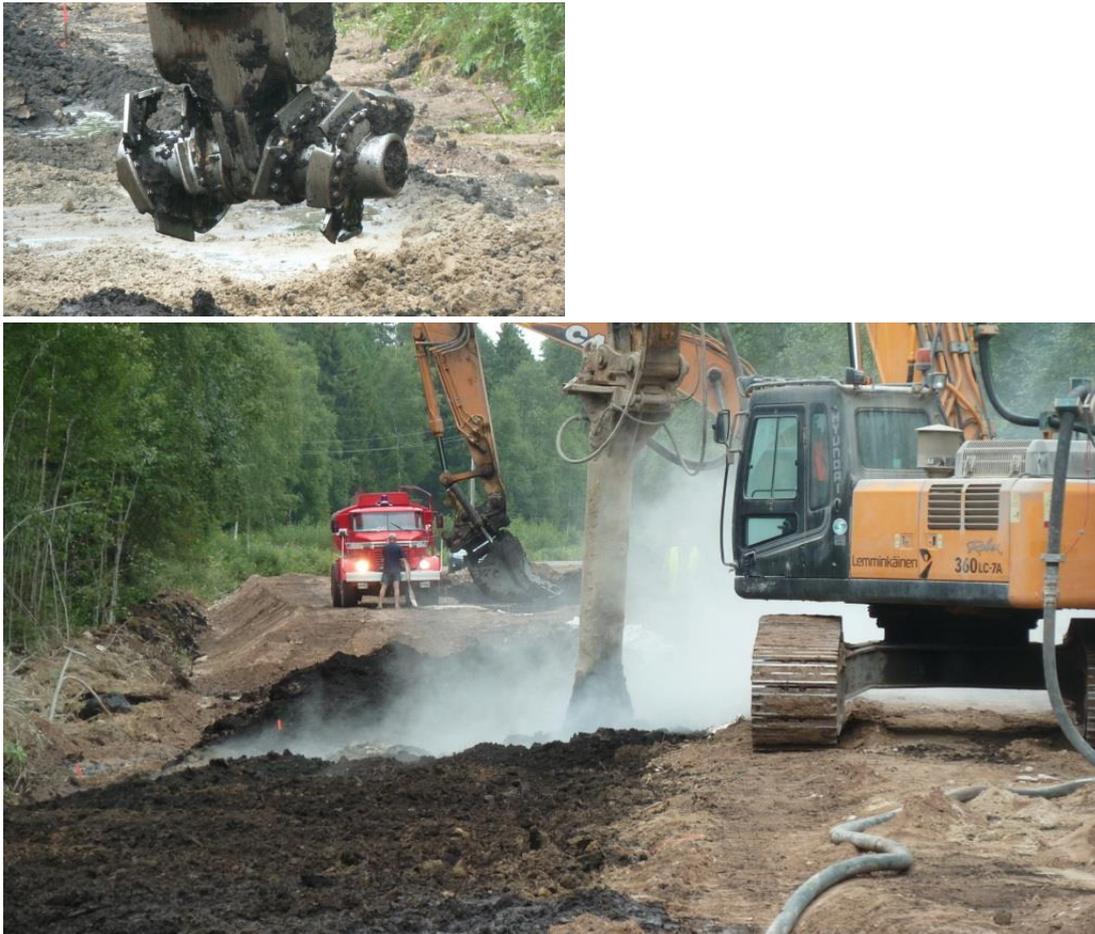
Photo 4-2 Mass-stabilisation works ongoing

Mass-stabilisation works carried on during **week 4** as also the road pavement excavation works. Scrap gravel was carried to the construction site from the quarry. Later on, the scrap gravel was profiled and squared off. Various stabilised road sections were coated with geotextiles and natural gravel was applied later on. During week four the following materials were received: EF PF, EF CFB and Composite Cement (CEM II / B-M (T-L) 42.5R).

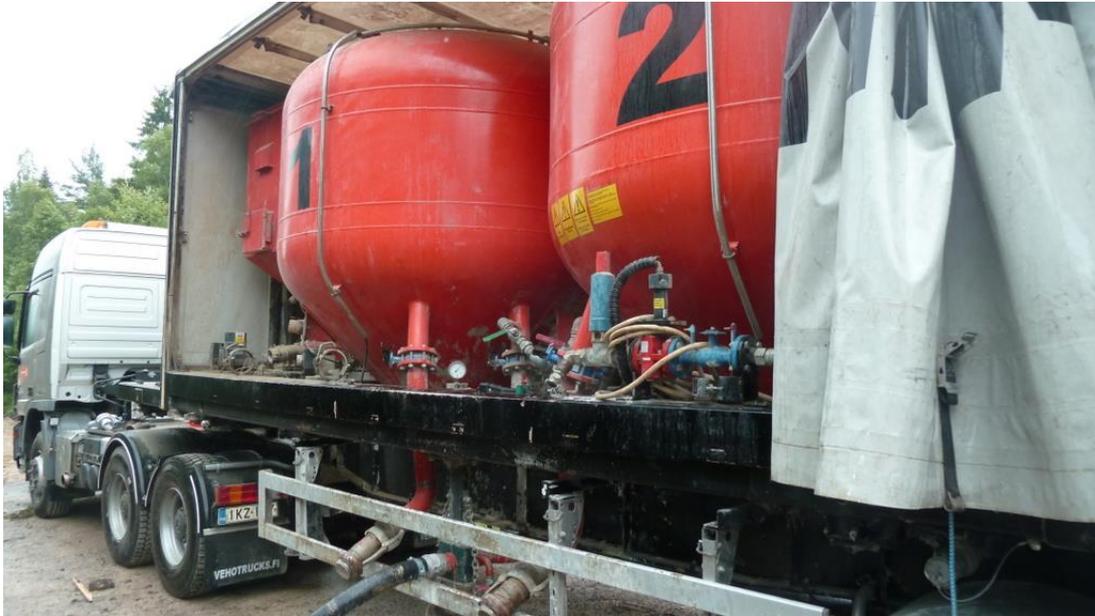
Photo 4-3 Binder material tanks (OSA and cement)

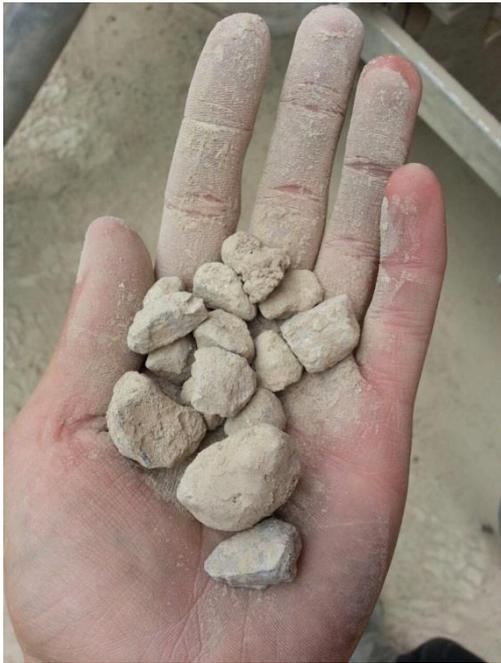
EF CFB ash contained small stones which caused chokings (see photo 4-5). One cargo was not usable at all because of very high quantity of stones. After technical improvements in plant the quality of ash was significantly improved and work process was going well compared with other two OSA qualities. Unit weight of EF CFB was smallest and that was one important factor. The temperature of the ash was higher in all loads.

Photo 4-5 Small stones in EF CFB

Based on the opinion of laboratory expert, the chemical structure of the ash was not reason for "clots". The reaction for the "clots" must be caused because of air moisture and its reaction with calcium.

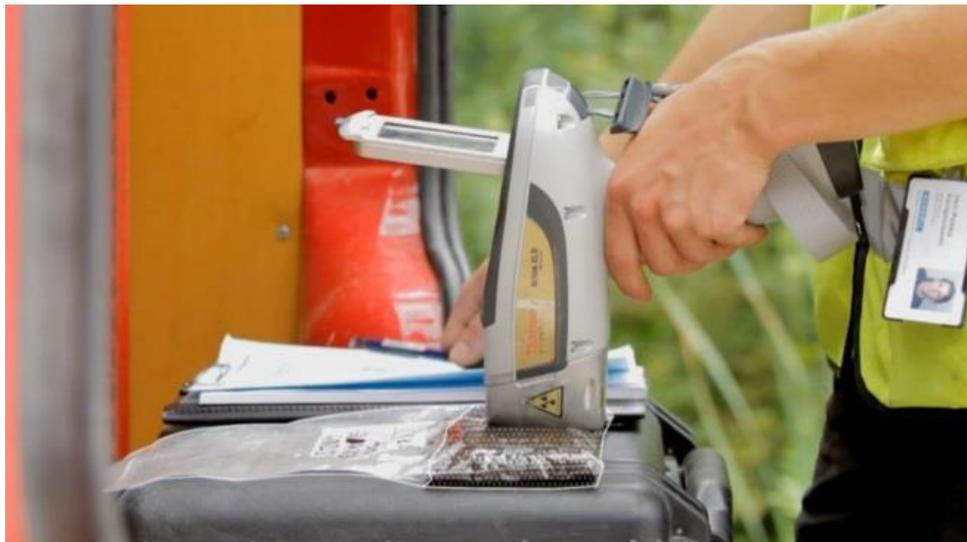
The XRF (X-ray fluorescence) analysis was used to measure the binder contents of the stabilised soil during the stabilisation process. Calcium content of the stabilised soil was determined with Niton XL3t X-ray fluorescence device (see photo 5-1). XRF is a type of spectroscopy that relies on the release and identification of element-specific wavelengths. The XRF device irradiates the sample causing a discharge of surplus energy. The device measures the wavelength and intensity of the emitted energy for element and recognizes amount, respectively.

Photo 5-1 XRF analysis ongoing

The Niton XL3t is a handheld device that is suitable for both on-site and laboratory measurements. This method is suitable for an application such as quality control of a peat stabilization project. In peat stabilization there is only one element of interest and it should be very abundant which makes the use of the device suitable for the purpose. The assumption behind this method is that the calcium content in the samples corresponds to the amount of binder and thus the success of the actual stabilisation work can be followed.

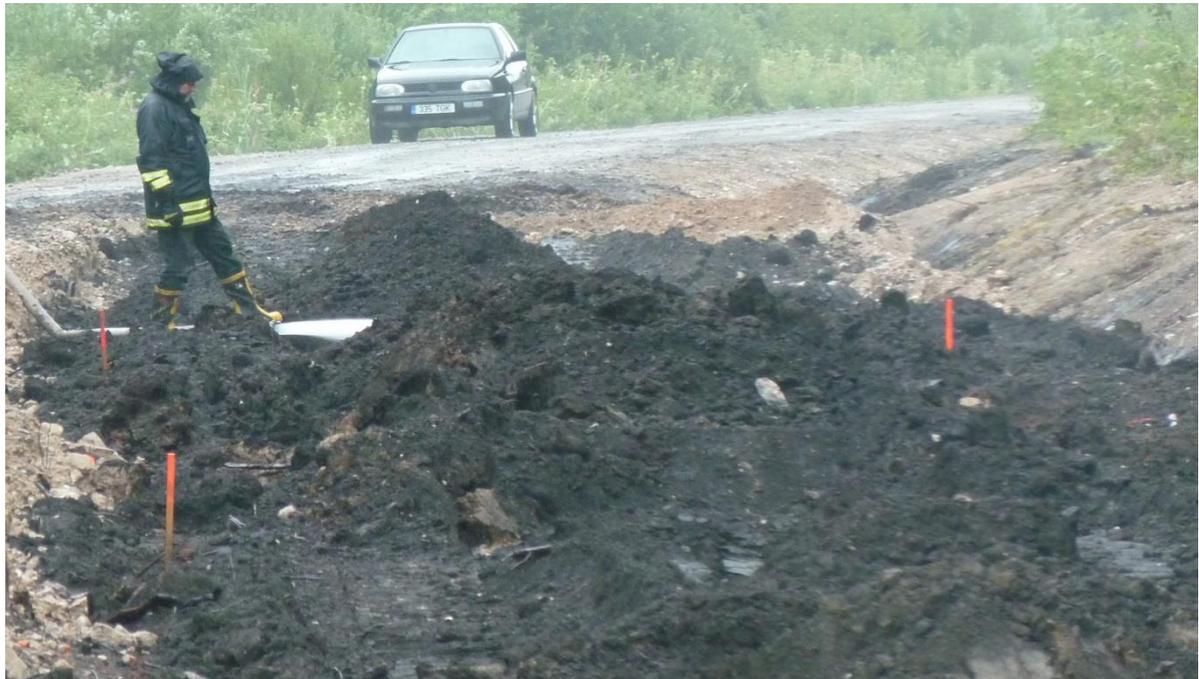
block by block and samples for XRF testing from different depths were taken from each block. In this way we have detailed information for the whole section about consistency of binder material.

Photo 5-2. Size of one block was 5m * 5m..

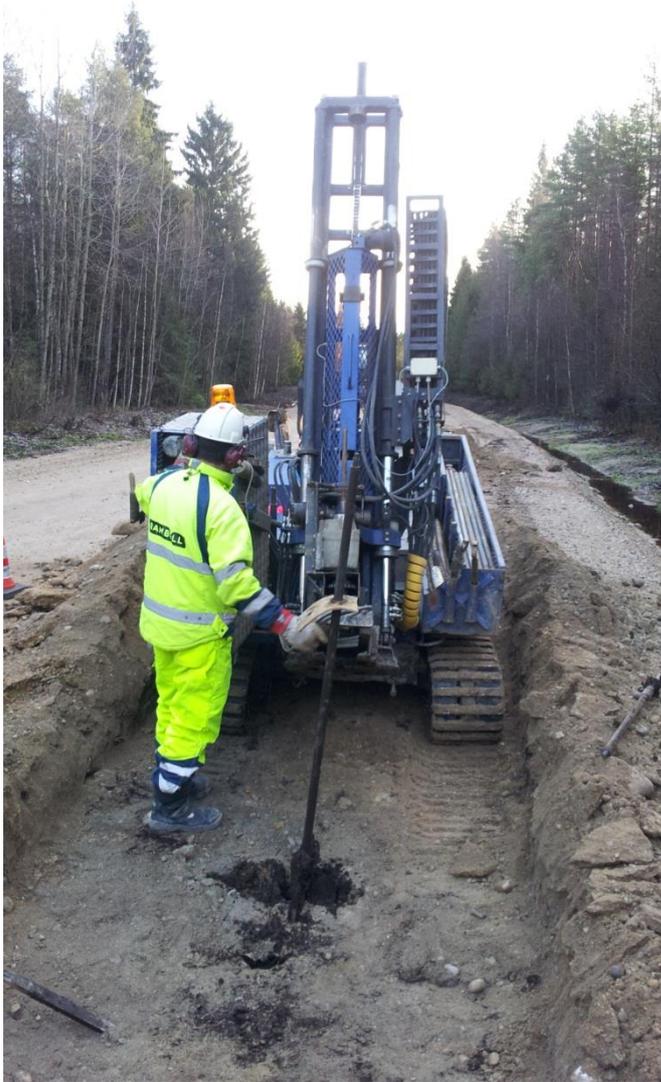
In order to acquire the results of the quality control soundings column penetrometer soundings were conducted. The aim was to test uniformity and homogeneity of the mass stabilised peat. The column penetration sounding is by far the most used method for the quality control of the column and mass stabilisation in Finland and Sweden. The method involves mechanical penetrometer that is equipped with two vanes. The penetrometer is pressed down and the compressive strength employed is measured at the upper end of the penetrometer rod. The width of the column sounding tip is 375 mm so the research area under the tip is about 400 mm x 80 mm (see photo 5-3). The method, however, is not flawless. In some cases on the basis of the column soundings it is virtually impossible to tell if the material examined is homogenous, with continuous structure ("a monolith") or if there is strength variations within the material, e.g. the material is a non-uniformly strengthened mixture of strengthened granules/lumps and un-strengthened soil.

Photo 5-3 Cone penetration and vane share tests ongoing

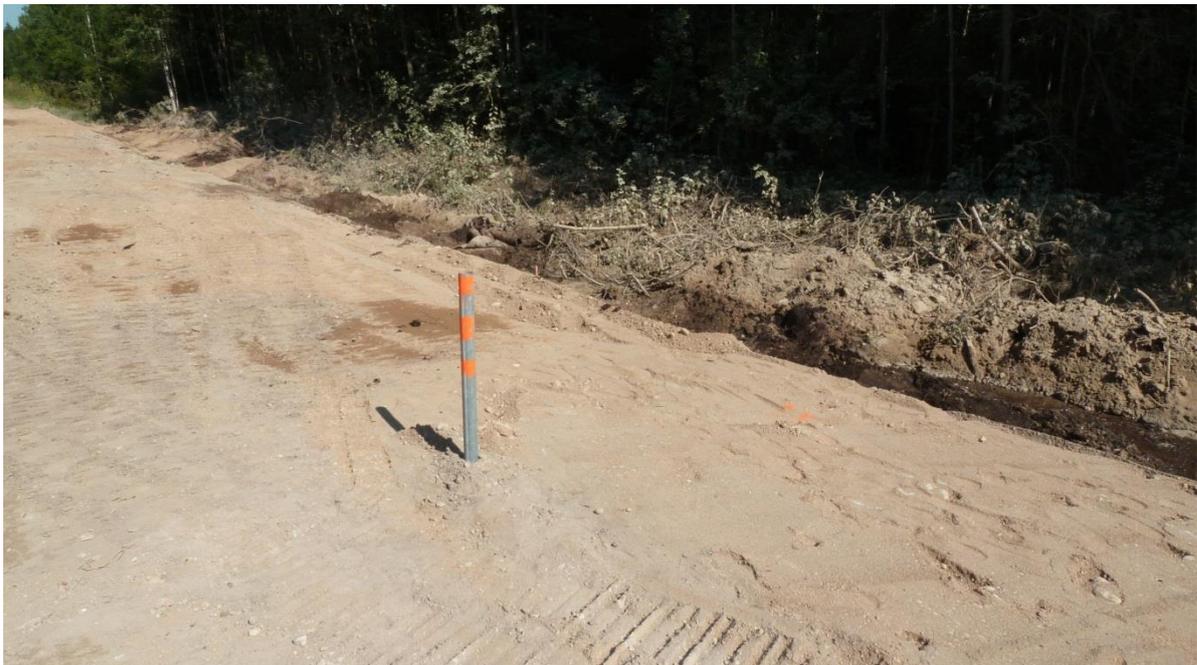
Five settlement plates were installed on the stabilised area (five cross sectional cut), which were used to measure the settlement of stabilisation of the structure. Settlement plates are square shaped steel plates with measuring sticks (2.5 m) attached on the middle of the plate. The settlement information was read on the measuring stick with tachymeter and current height was compared to the level zero which was read right after the installation. The settlement plates were installed on the top of the stabilised structure. The pre-loading embankment material was put back carefully to prevent the deformation of the measuring stick (see photo 5-4).

Photo 5-4 Location of the survey plate on site
