**Eesti Energia AS**

**Survey report / Uuringu aruanne**

# **LIFE+ 09/ENV/227 OSAMAT ENVIRONMENTAL SURVEY RE- SULTS / KESKKONNASEIRE TULEMUSED**

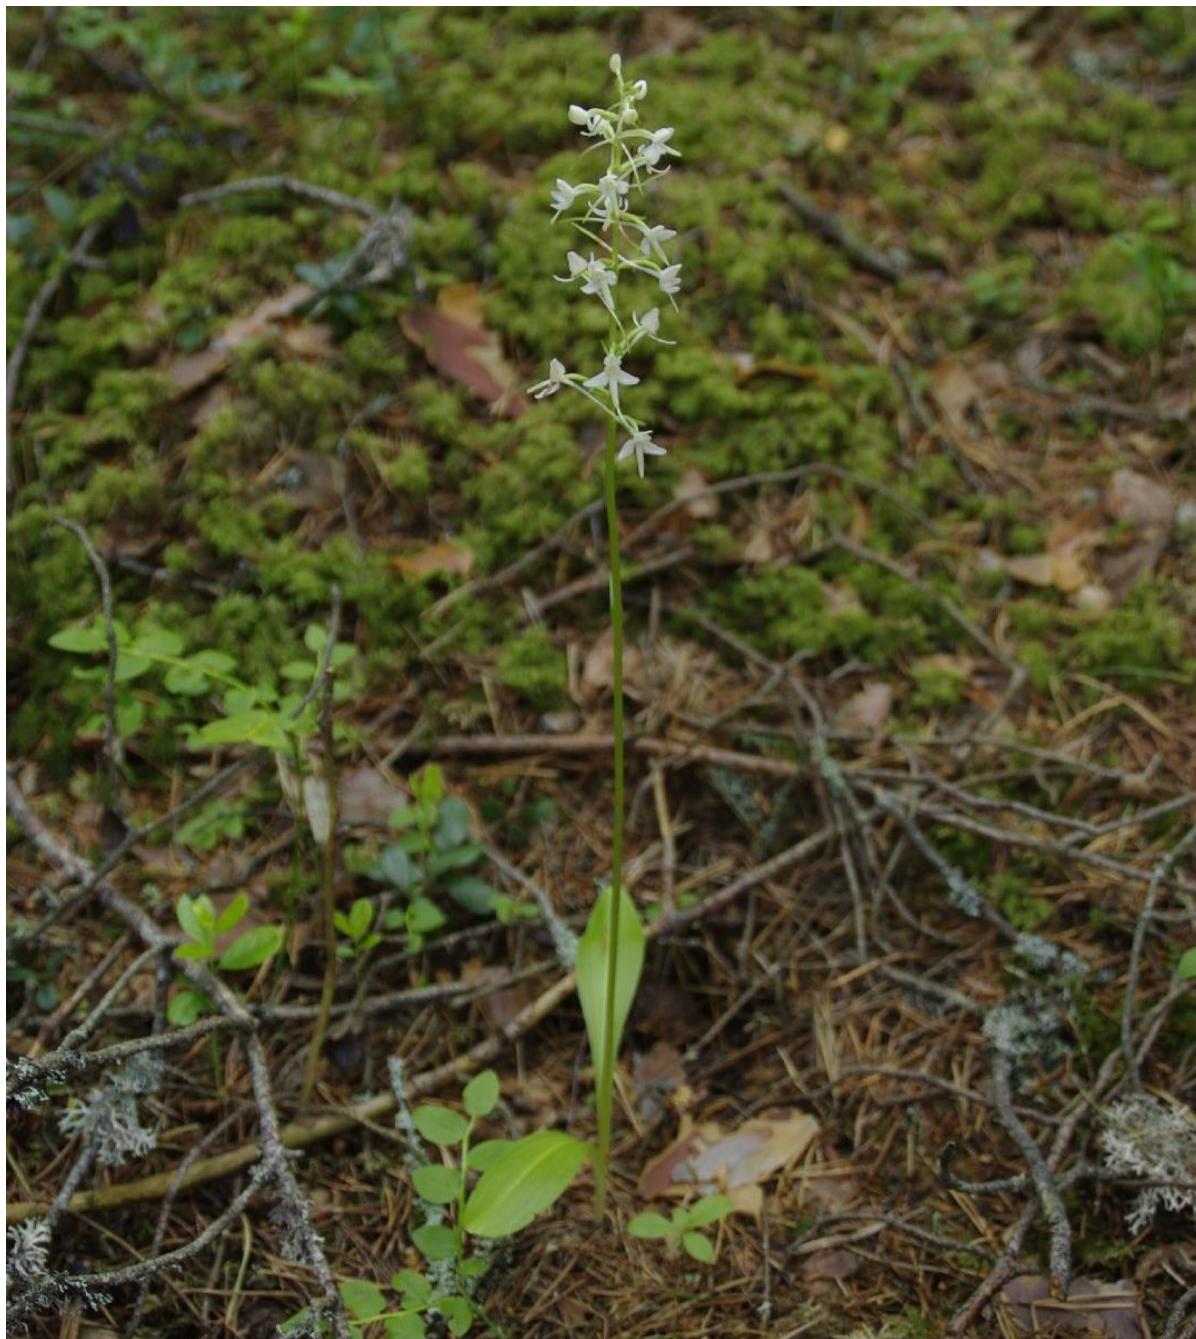
Kogu 2,5-5 km teelõiku ääristavates metsades esineb hajusalt üksikuid III kaitsekategooriasse kuuluva kahelehise käokeele (*Platanthera bifolia*) isendeid. Liik on piirkonnas tavalline ja laialt levinud ning teega piirneva ala puhul pole tegemist liigi jaoks kuigi olulise elupaigaga.

**Figure 4. Individually scattered Category III protected species in the forest surrounding the Simuna-Vaiatu road section - Lesser Butterfly-orchid (*Platanthera bifolia*) / Simuna-Vaiatu teelöiku ääristavates metsades esineb hajusalt üksikuid III kaitsekategooriasse kuuluva kahelehise käokeele isendeid (*Platanthera bifolia*) (20.06.2011 R. Pajula)**

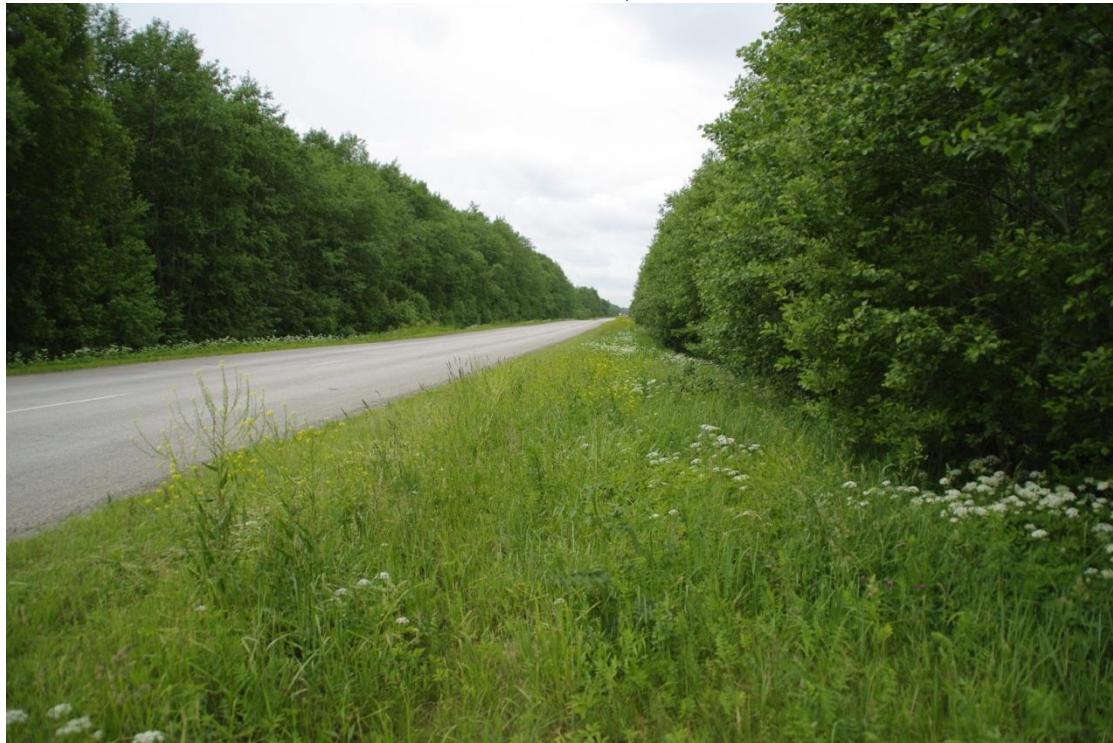
**Figure 6. View on the road section in summer 2011 before the start of the reconstruction / Vaade teelõigule 2011. aasta suvel enne rekonstrukeerimistööde algust**

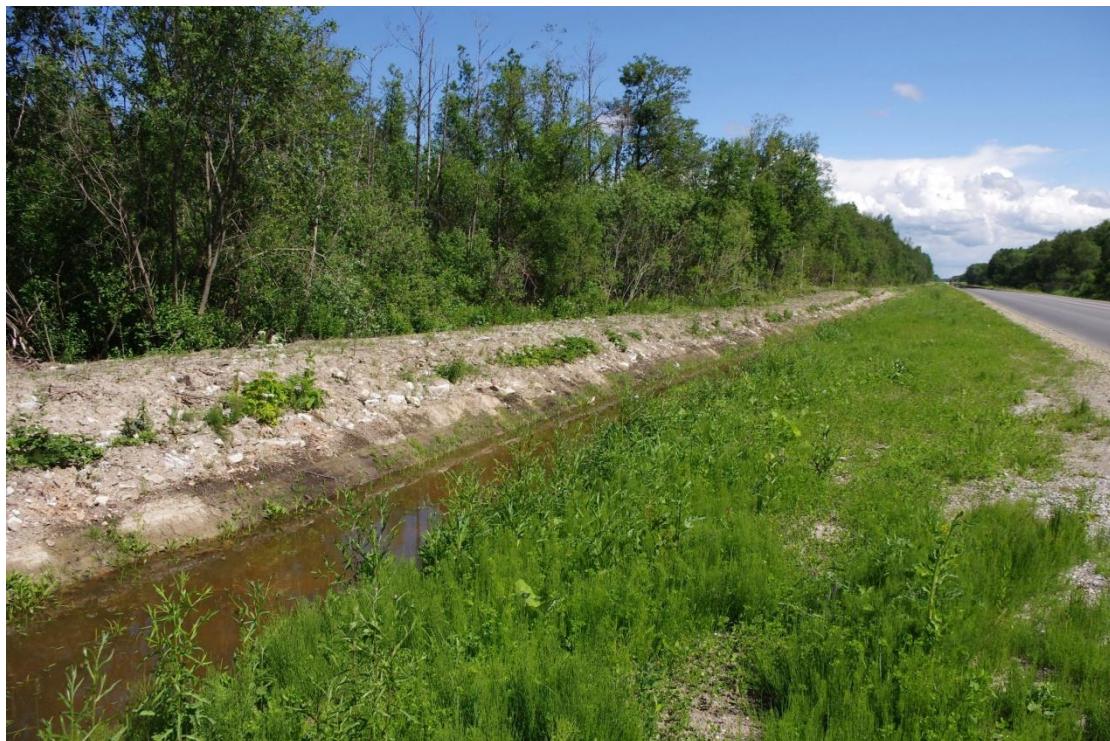
**Figure 7. View on the test section after completing the works / Vaade katselöigule pä-rast tööde lõppu (29.06.2012, R. Pajula)**

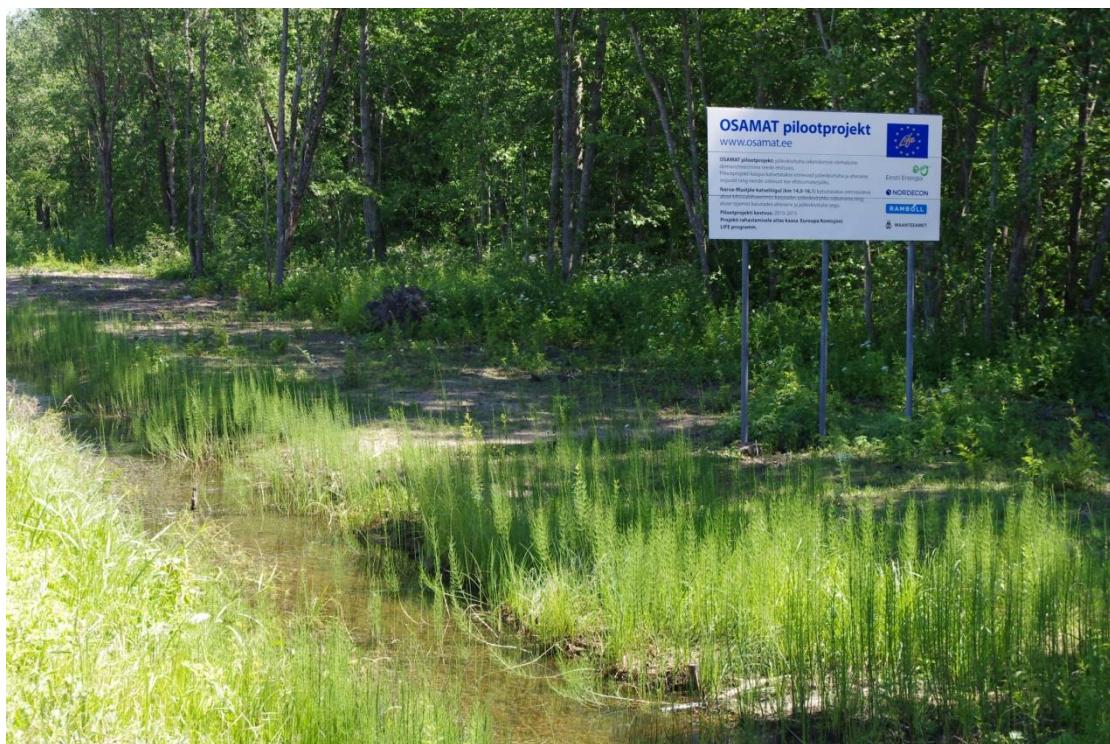
**Figure 8. Organized and spontaneously re-vegetating roadside area / Korrastatud ja taastaimestuv teeäärne ala (29.06.2012, R. Pajula)**

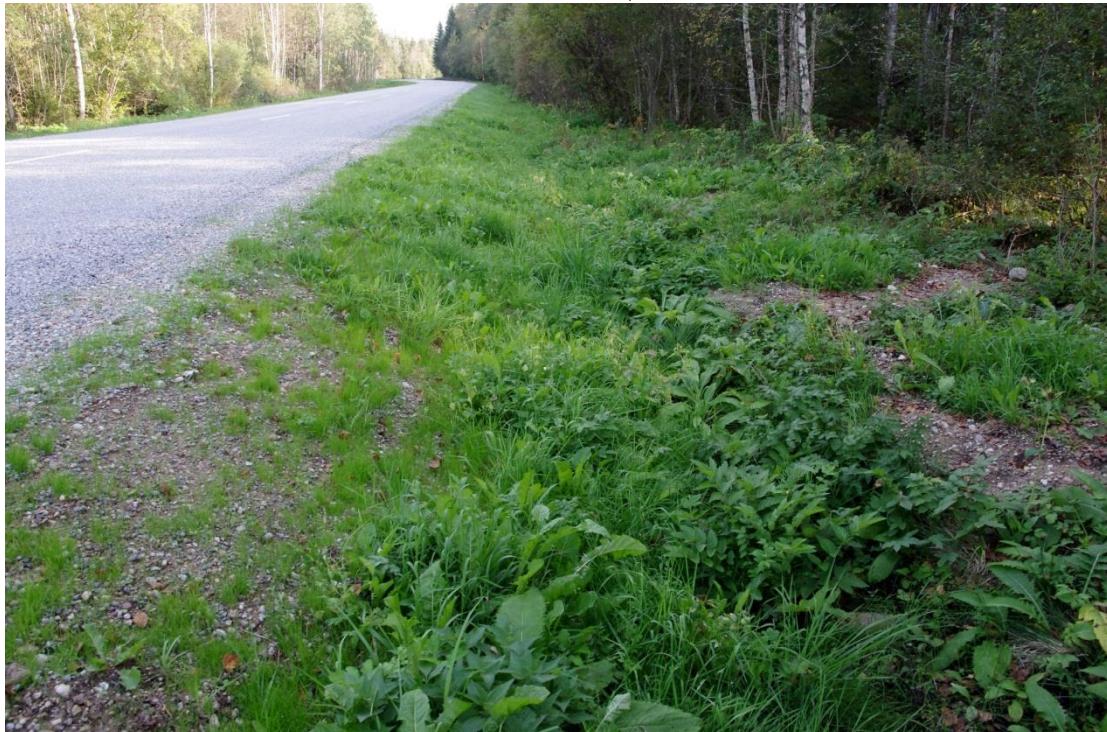
**Figure 14. The vegetation in the right (western side) road edge of the northern part of the test section in 2014, view looking to the south (2014, R. Pajula) / Katselöigu põhjaosa parema (läänepoolse) teeserva taimkate 2014. aastal alal, kus kulgkraav puudub, vaade louna suunas (2014, R. Pajula)**

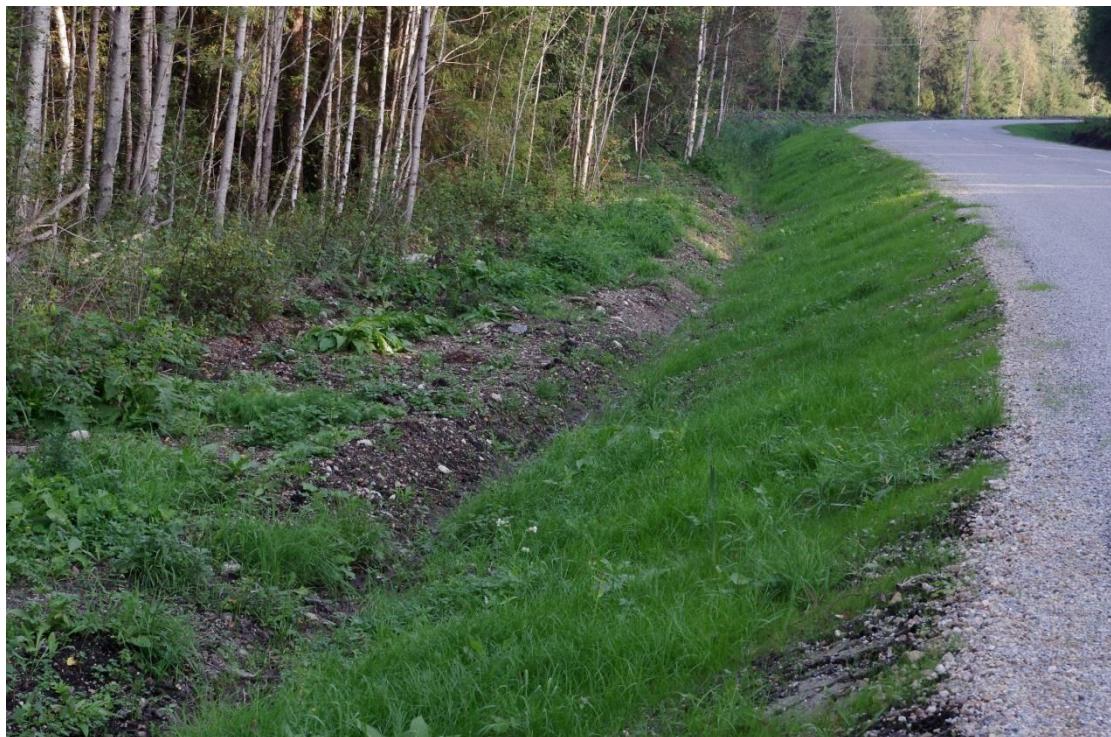
**Figure 15. The vegetation in the left (eastern side) road edge of the northern side of the test section in 2014, view looking to the south (2014, R. Pajula) / Katselõigu põhjaosa vasaku (idapoolse) teeserva taimkate 2014. aastal, vaade lõuna suunas. Mulde nõlvale on külvatus muru (2014, R. Pajula)**
